# **Tissue Machine Bearing Failure and PeakVue Problem Resolution**

## Introduction

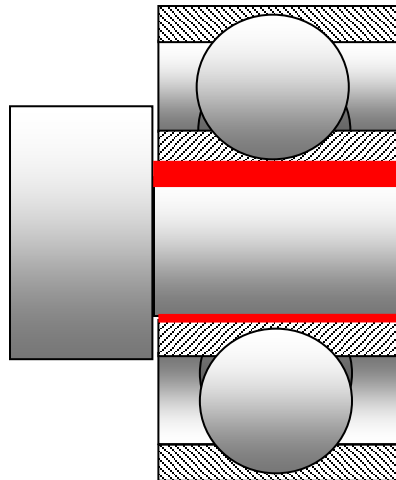
On November 23, 2005, the 16 Tissue Machine After-dryer T3 tending-side bearing had a significant failure. The bearing failed after an audible noise and high temperature was noted on the bearing housing. Upon inspection of the front side bearing, a 1/8" drop in the bearing position was observed; the inner race and the retaining ring were not found in their correct positions. Two of the three lock down bolts were missing with one bolt sheared off, resulting in bearing and journal damage. The other missing bolt disintegrated, its debris is believed to have plugged the oil return line. The last bolt was in position, partially holding the retaining ring. Oil flowing into the bearing housing indicated that the bearing had lubrication before failure. Six of the eight front-side After-dryer bearings were inspected during this repair, and nothing was found out-of-standard.

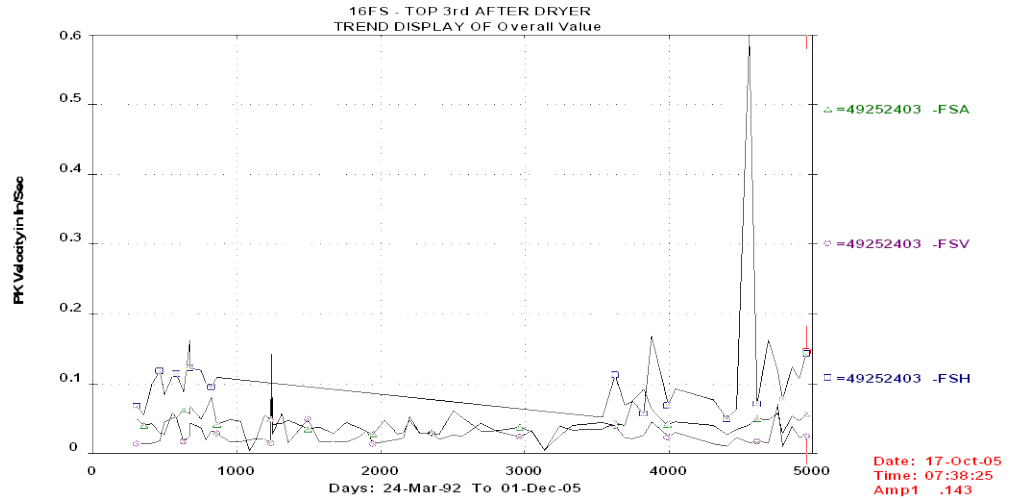
Aside from a minor increase in the axial amplitude, the vibration data from October 17<sup>th</sup> did not show any signs of defect prior to the bearing failure. As a result of the audible noise emanating from the bearing, an inspection was recommended. Shortly after these readings, the T3 bearing failed before a shutdown inspection could be performed. After this failure, PeakVue monitoring was added to the route for all tissue machine rolls.

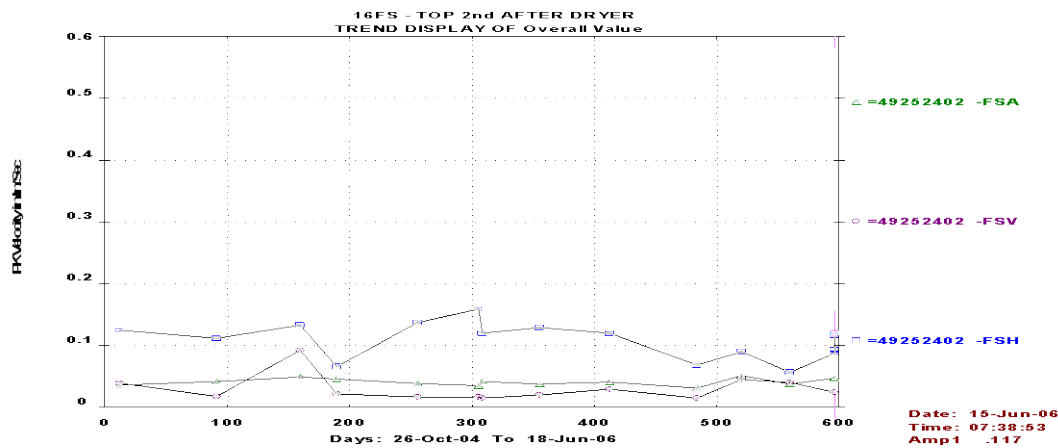
On June 15, 2006, vibration analysis was requested on the 16TM T2 After-dryer tending-side bearing. This was on the same After-dryer section of the tissue machine as the previous failure. An intermittent audible noise was emanating from the F/S T2 bearing. Vibration data was collected on the bearing along with PeakVue readings. Horizontal, vertical and axial vibration amplitudes were low, below 0.12 ips on the bearing housing readings.

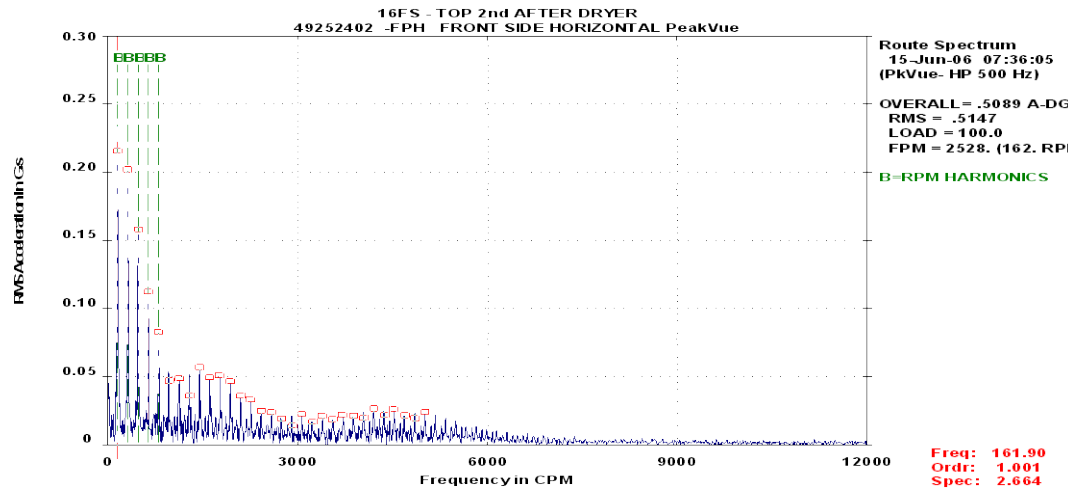
PeakVue data contained multiples of TS, and the overall PeakVue value increased when the audible noise was louder.

Multiples of turning speed is typically indicative of looseness in vibration readings. The multiples of turning speed in the PeakVue data reached 3.4 G's p-p when the audible noise was at its highest value. This may have been from load variations on the bearing. Although PeakVue amplitudes were low, severe damage was found during the maintenance inspection. When multiples of turning speed is indicated in PeakVue measurements, maintenance inspection of the bearing should be considered to avoid failure of the machine component.

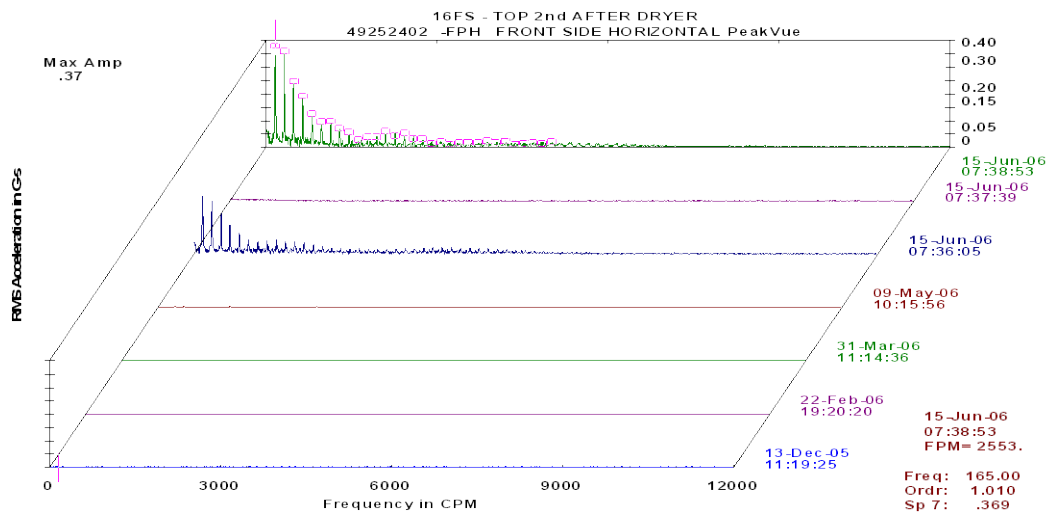
Three PeakVue readings were collected at that time, which are displayed in the waterfall plot below. The middle June 15<sup>th</sup> reading was taken when the audible noise decreased. An analysis of the collected data was performed and a report generated. Recommendations were made to increase monitoring of the bearing PeakVue and temperature values until maintenance could be performed. An inspection of the bearing for looseness or wear was also recommended at the next opportunity.

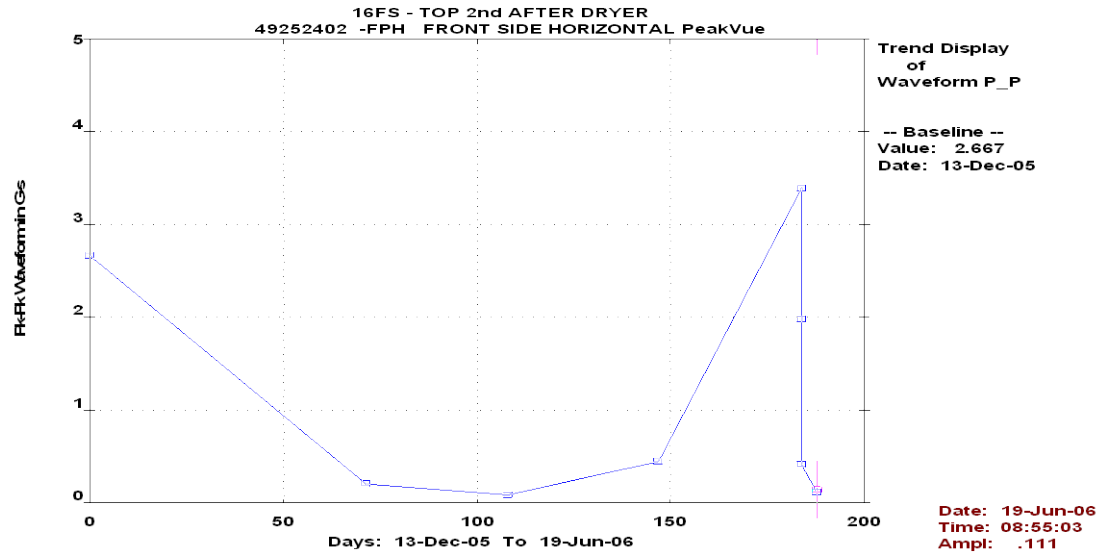
Because of production requirements, the bearing was flooded with oil to maintain TM operation. Readings on June 19, 2006 found that the audible noise and PeakVue values decreased. The problem still exists but

was masked by excessive bearing oil.  
Recommendations to inspect the bearing and perform monitoring until maintenance was possible were reiterated.

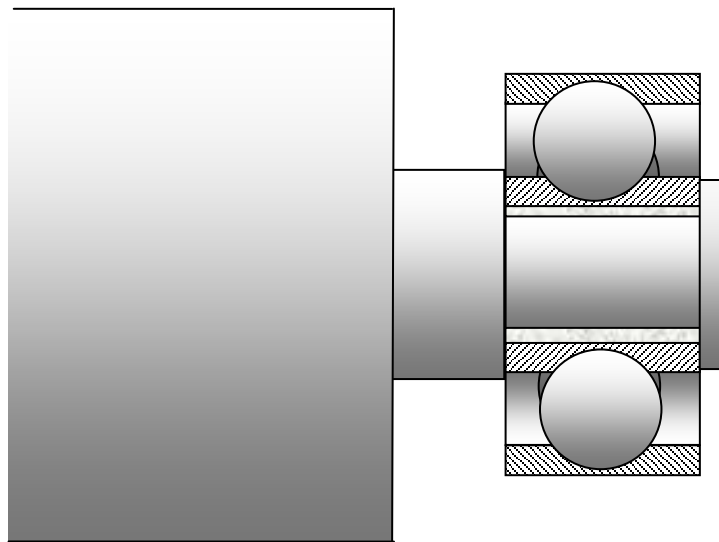
A TM shutdown was scheduled for June 20th and an inspection of the After-dryer T2 Roll bearing was performed at that time. The inner race was found to be loose on the shaft. Measurements on the journal found it to be severely worn where the bearing inner race was spinning on the shaft. A compression fit is used on this configuration to hold the inner race in-place on the roll journal. The journal was machined and a sleeve was installed along with a new bearing.
