Arabian Cement Company Avoids Costly Unplanned Downtime By Solving Complex Vibration Problem

Motor-driven hammer crusher, located at the end of the grate cooler on No. 1 kiln, is capable of crushing 1200 tons per day of cement clinker.

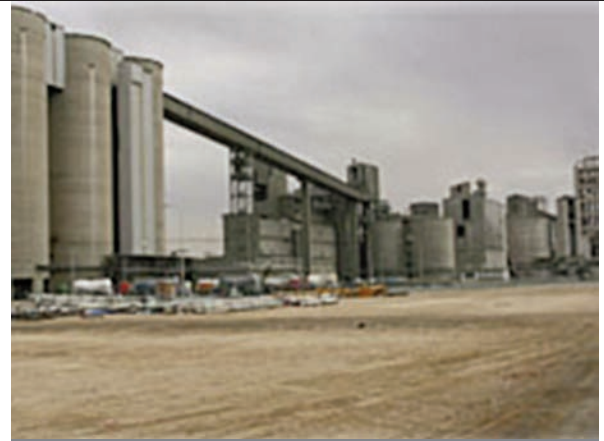
Using Emerson’s CSI 2130 Machinery Health® Analyzer with slow speed technology kit and AMS® Suite: Machinery Health Manager, Predictive Maintenance Engineer Ahmed Ibrahim discovered a severe vibration (11.14 mm/s overall) at the harmonics of the motor’s rotational speed from 1X to 20X, indicating that despite previous repair efforts the vibration problem was indeed getting worse.
