PeakVue Analysis for Antifriction Bearing Fault Detection

Peak values (PeakVue) are observed over sequential discrete time intervals, captured, and analyzed. The analyses are the (a) peak values (measured in g's), (b) spectra computed from the peak value time waveform, and (c) the autocorrelation coefficient computed from the peak value time waveform.

Case studies of various classes of faults are presented to illustrate the PeakVue methodology. The classes of faults are (a) inner race defects, (b) outer race defects, (c) rolling element defects, and (d) cage related defects. All three analysis tools enable the identification of the defect and often the severity of the defect.

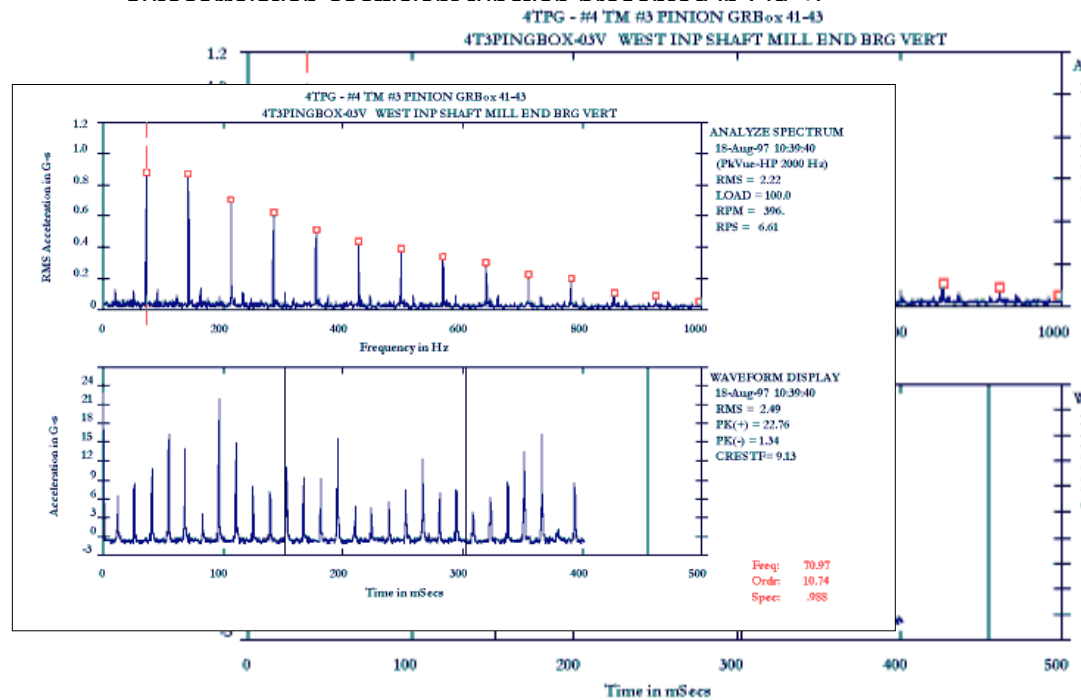
The PeakVue spectra and time waveform data are presented in Fig. 1. A high pass filter of 1000 Hz was used. Significant activity at the outer race defect frequency with many harmonics is present. The impact levels are as high as 37 g's.

Although many harmonics are present in the spectral data, it is obvious from the PeakVue time waveform that the time between impacts corresponds to the outer race fault frequency (the harmonics are of no physical significance). This is also demonstrated in the

Figure 1: PeakVue Spectra and time waveform from input shaft of pinion stand gearbox

The impacting levels trended from 18 g's in July to a high of 37 g's in September. The levels had decreased to 14 g's in October prior to a bearing replacement.

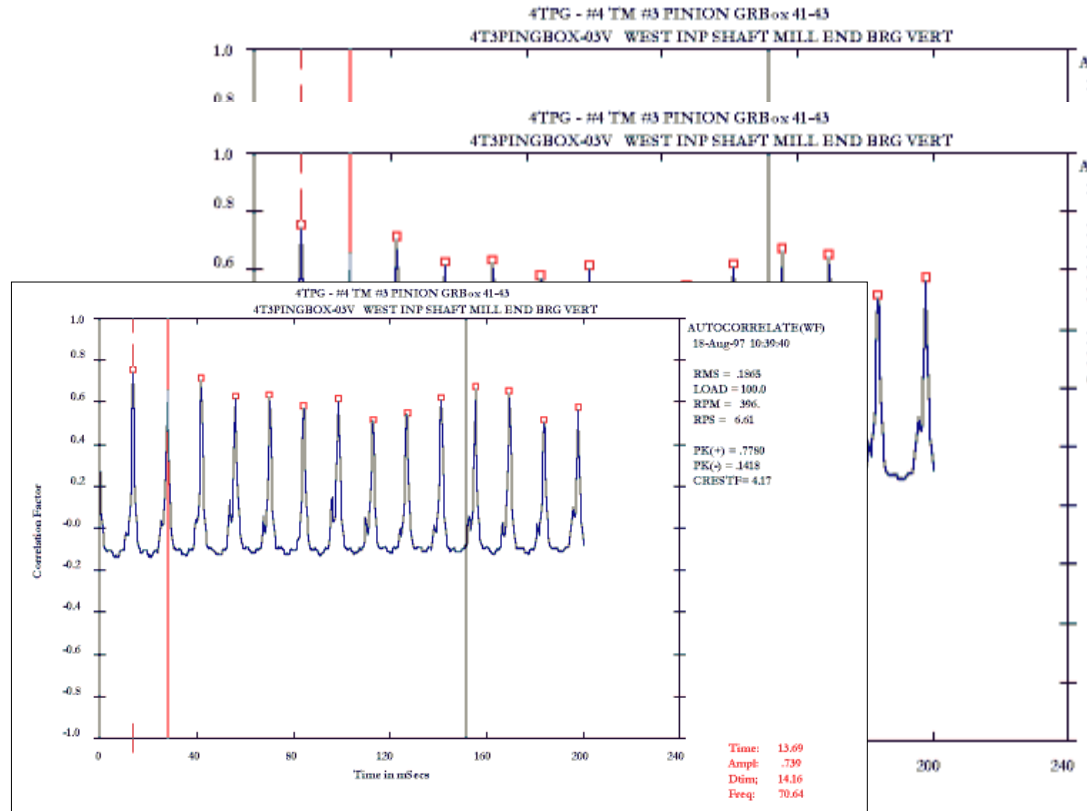
Figure 2: Autocorrelation coefficient from PeakVue time waveform in Fig 1

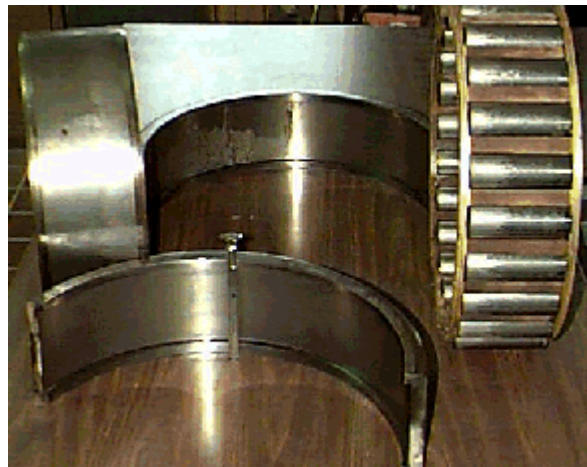
Figure 3: Photograph of defective bearing from the inlet of pinion stand gearbox

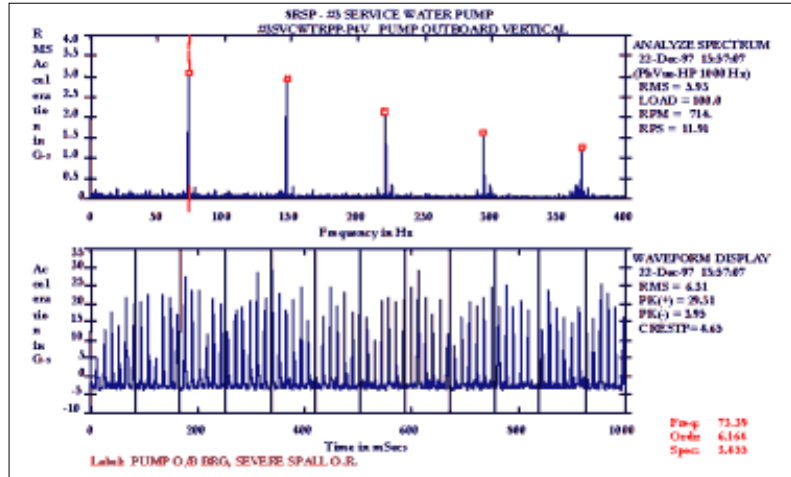
and inner race defects with a signal level of 10 g's. A second PeakVue reading was taken on December 22, 1997 and is presented in Fig. 4. The impacting levels had increased to 33 g's. The pump was then placed on the "fault" level and the bearing was replaced. The autocorrelation coefficient computed from the PeakVue time waveform is presented in Fig 5. The autocorrelation coefficient data shows the only activity of significance is the impacting from the outer race defect.

Figure 4: PeakVue spectra and time waveform from outboard on service water pump

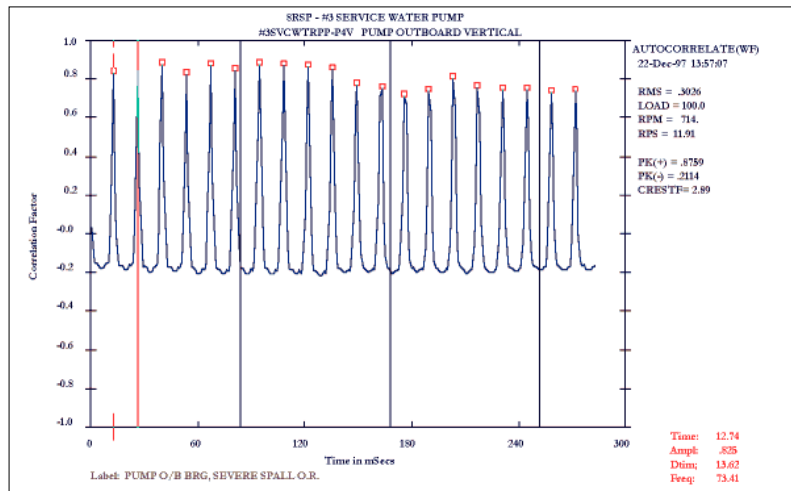
Figure 5: Autocorrelation coefficient from PeakVue waveform in Figure 4.

In this case, normal vibration data did identify the fault; however, the low levels observed did not place the fault at a level of significant concern. The impacting levels identified in PeakVue, excess of 30 g's, raised the concern level and initiated planning for replacement.

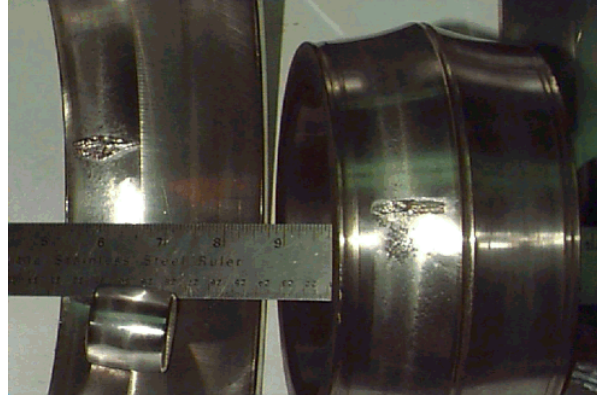
Figure 6: Photograph of defective service water pump bearing, showing inner and outer race spalling.

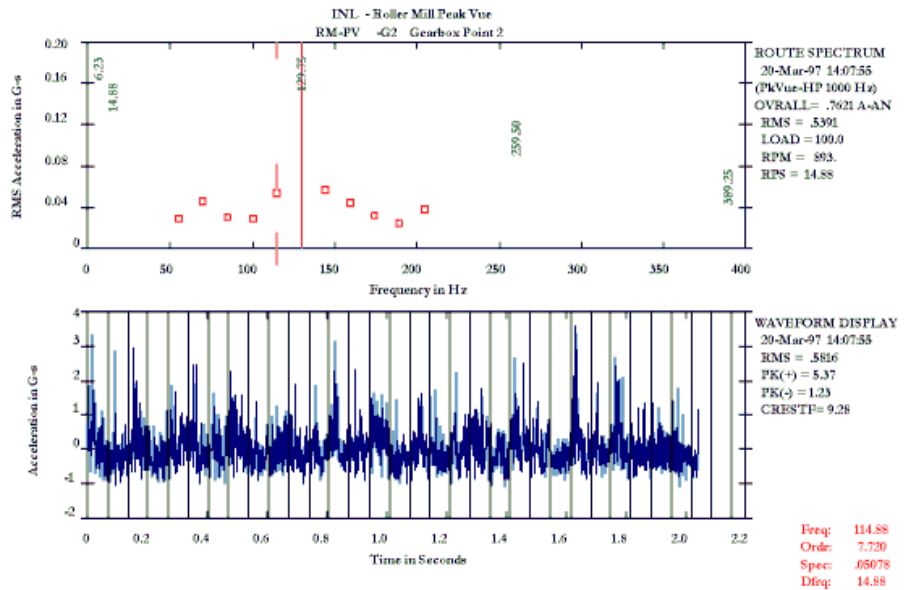
The PeakVue data acquired March 20, 1997 are presented in Fig. 7. The cage activity at 6.23 Hz (0.42 orders) is identified. The inner race defect (129.75 Hz) at 8.72 orders is being sidebanded by running speed. The inner race defect was not detected in the normal

Figure 7. PeakVue spectra and time waveform from inlet of crusher gear box.

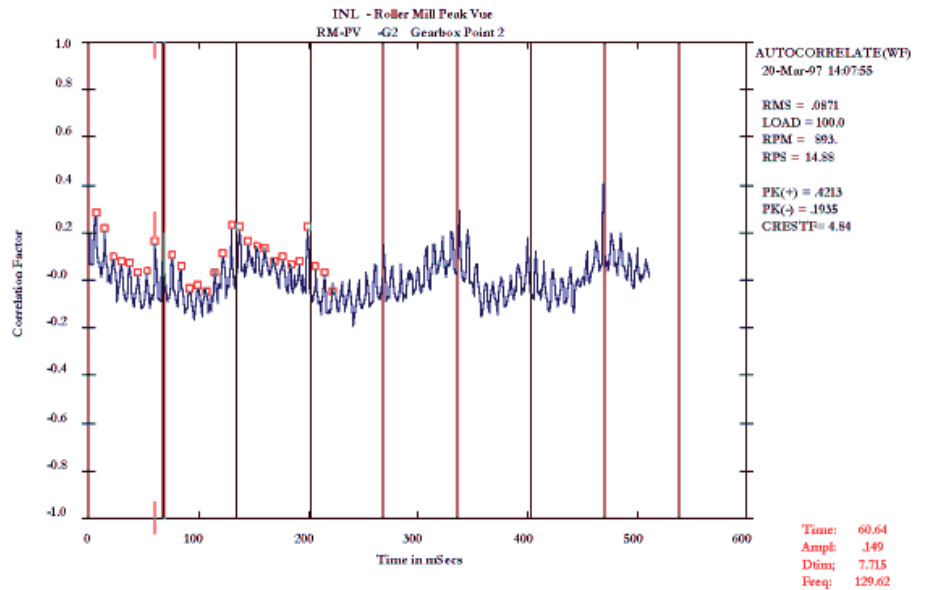
Figure 8. Autocorrelation coefficient from PeakVue time waveform of Figure 7.

The autocorrelation coefficient function computed from the PeakVue time waveform in Fig. 7 is presented in Fig. 8. The inner race defect is clearly evident with amplitude modulation at running speed. The peak g levels for an inner race are generally not as large as for those accompanying an outer race defect. This is expected since the stress waves accompanying an inner race defect will experience attenuation in reaching the outer

The bearing was replaced in June, 1997. The inner race had deep spalling over an approximate 1 1.5 area.

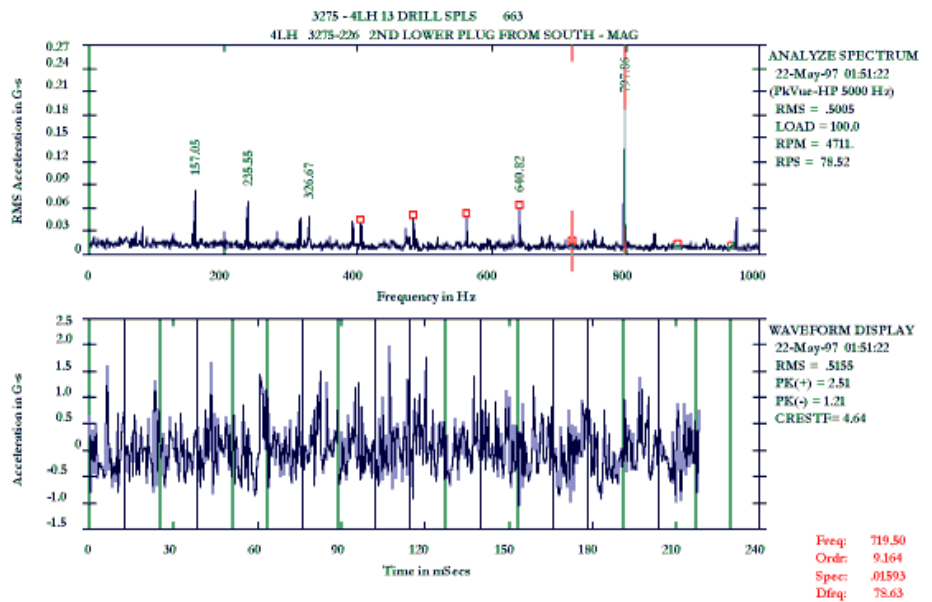
Figure 9. PeakVue spectra and time waveform from a spindle on a 13 multi-drill head spindle.

The PeakVue spectra and time waveform for a spindle with a confirmed inner race defect are presented in Fig. 9. The inner race defect at 797.86 (10.2 orders) Hz is identified with side banding (twice running speed is dominant). The autocorrelation coefficient function computed from the PeakVue time waveform is presented in Fig. 10. The dominant activity here is at the inner race defect frequency. The bearing was replaced. The bearing had deep spalling on the inner race

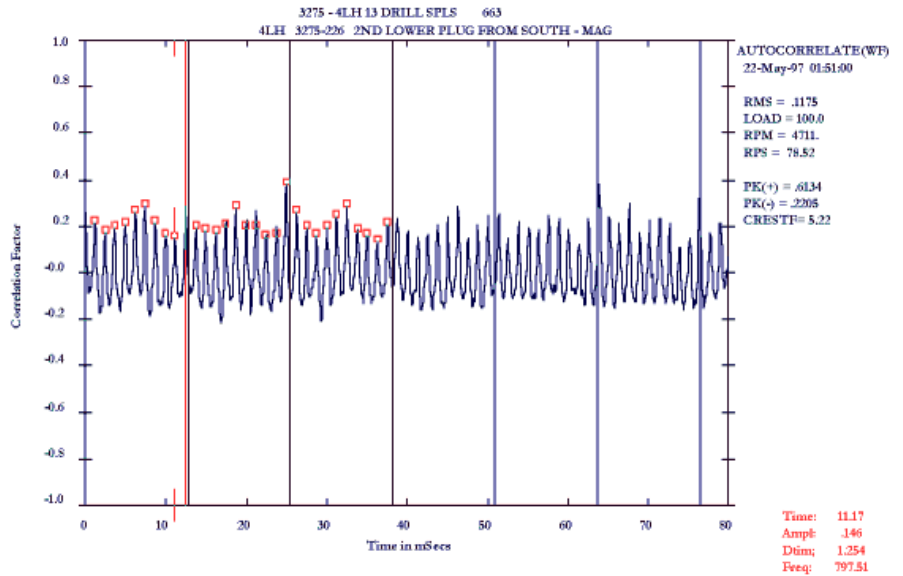
Figure 10. Autocorrelation coefficient from PeakVue time waveform acquired on the spindle of Figure 9.

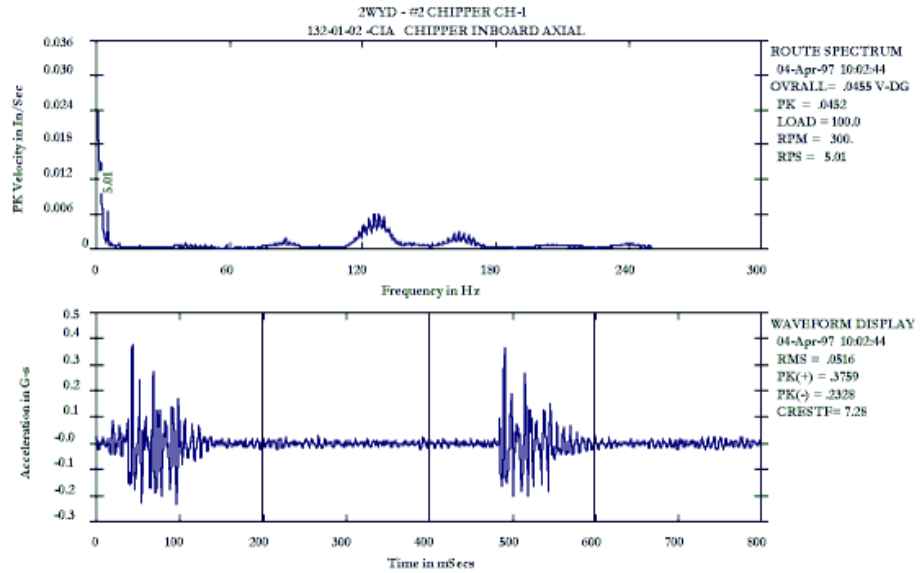
Following a shutdown where work was done on this chipper machine, the acceleration time waveform for a 500 Hz bandwidth spectra indicated some impacting may be occurring, see Fig. 11. The p-p g levels were less than 1 g which are not judged to be significant. The velocity spectra had a low 1x component but there were no obvious bearing faults.

Figure 11. Velocity spectra and acceleration time waveform from inboard axial on a chipper.

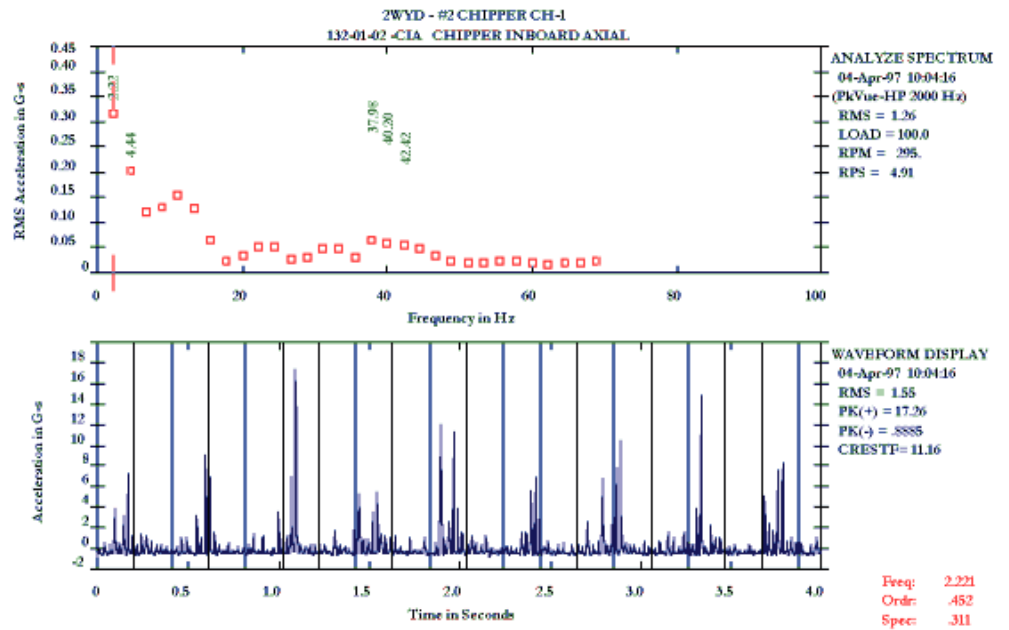
Figure 12. PeakVue Spectra and time waveform from inboard axial on chipper.

A PeakVue data set was acquired at about the same time using a high pass filter of 2000 Hz. The resulting PeakVue spectra and time waveform are presented in Fig 12. The impacting level is near 20 g's and the cage and twice ball spin frequencies are dominant. This pattern is indicative of two impacts per revolution of the ball that is passing through the load zone at the cage repetition rate. From the PeakVue spectral data, it is not obvious whether the 38, 40.2, or 42.4 Hz peaks are representative of twice ball spin. The autocorrelation coefficient function data, presented in Fig. 13 clearly identifies the dominant activity is at 40.2 Hz which is twice the ball spin frequency. The autocorrelation coefficient data also clearly shows the defective ball going in and out of the load zone at the cage turning speed.

The root cause of this problem was found to be improper grounding of an electrical welder used during the recent outage.

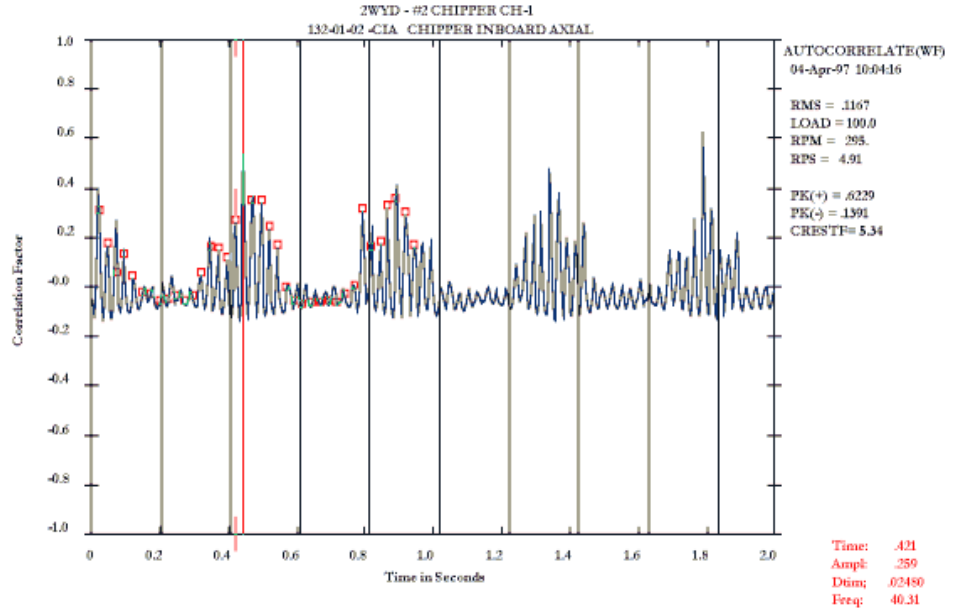
Figure 13. Autocorrelation coefficient from PeakVue time waveform of Figure 12.

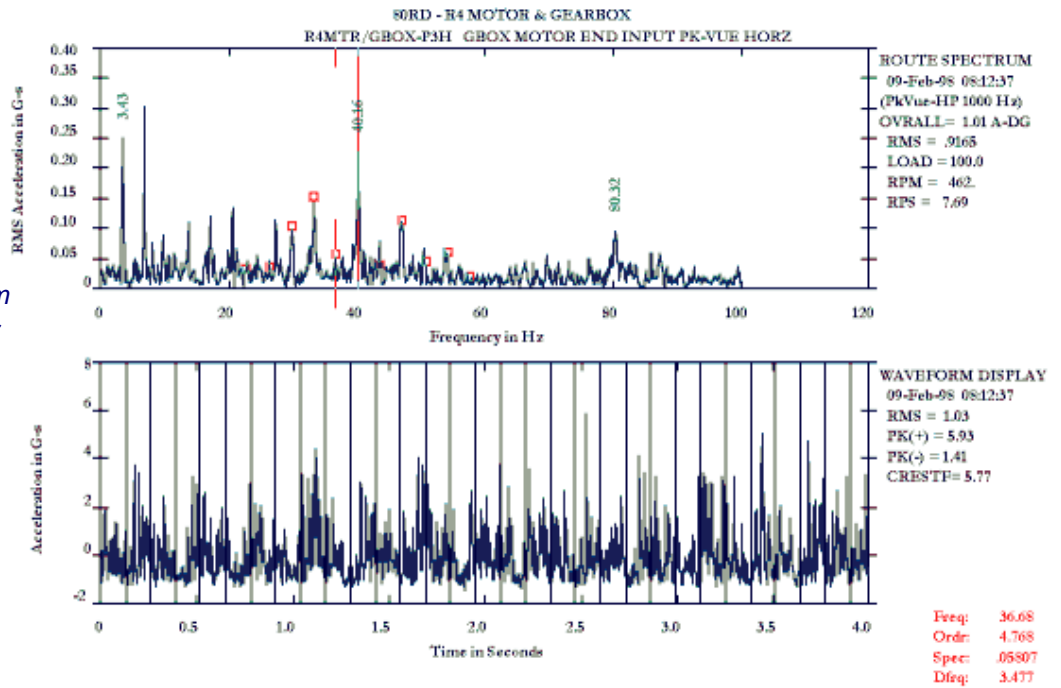
When data was acquired on the inlet pinion shaft bearing on January 2, 1997, impacts in the 6 g range were detected with the PeakVue spectra showing ball spin fault modulated by cage. On February 9, 1997, the impacting level had increased to 9 g's. The PeakVue data are presented in Fig 14. The ball spin fault frequency is at 40.4 Hz and cage at 3.43 Hz. The autocorrelation coefficient is presented in Fig. 15 which

Figure 14. PeakVue Spectra and time waveform from inboard pinion rougher gear box.

The bearing was replaced and PeakVue data acquired on February 12, 1997. The impacting level had decreased to less than 1 g. The normal vibration never showed any indication of a bearing problem.

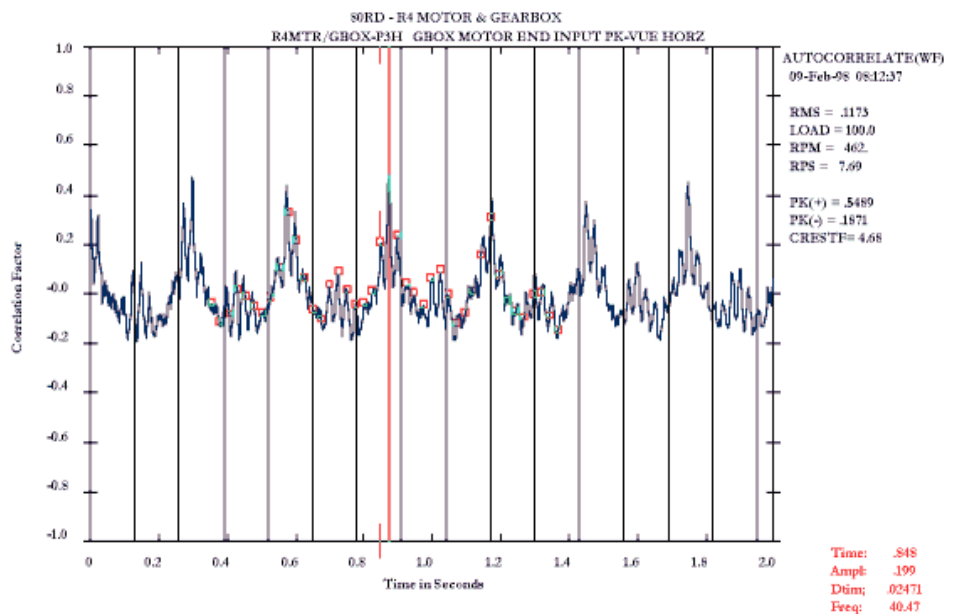
emphasizes the cage and ball activity. A photo of the defective bearing is presented in Fig. 16.

Figure 15. Autocorrelation coefficient from PeakVue time waveform of Figure 14.

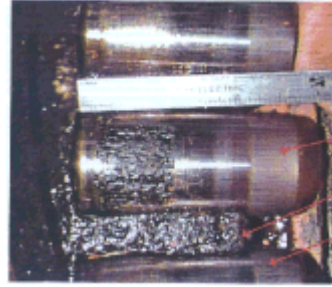
Figure 16. Photograph of defective bearing highlighting the rollers.

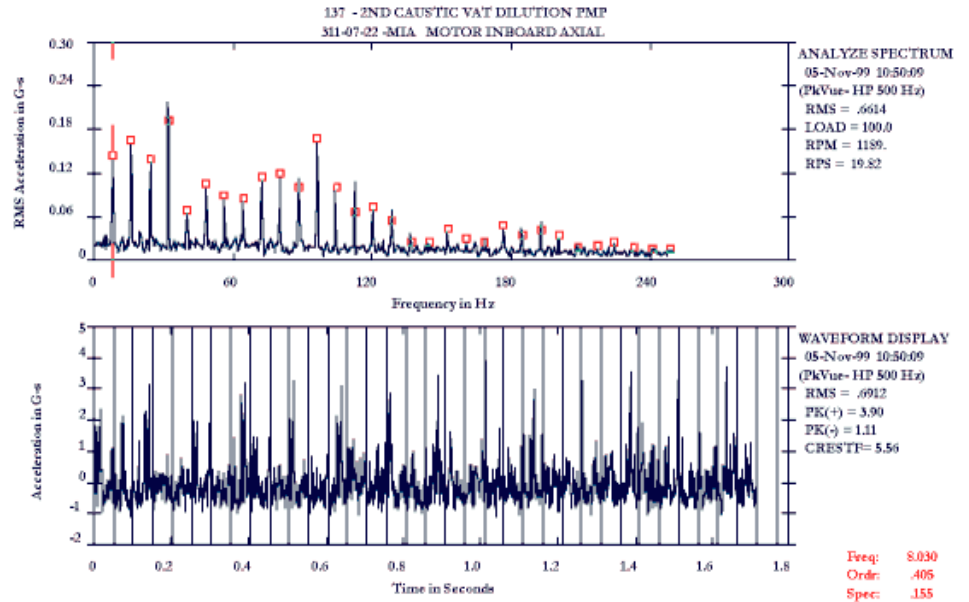
The PeakVue data from the inboard bearing on a motor (150 hp) directly driving a centrifugal pump are presented in Fig. 17.

Figure 17. PeakVue spectra and time waveform from Motor (Inboard Axial) driving direct coupled centrifugal pump.

The impacting levels are 5 g's which are not excessive for this speed machine but definitely indicative of a problem. The spectral data is dominated with cage and many harmonics. This is a NSK NU 318 bearing which has 13 rolling elements.

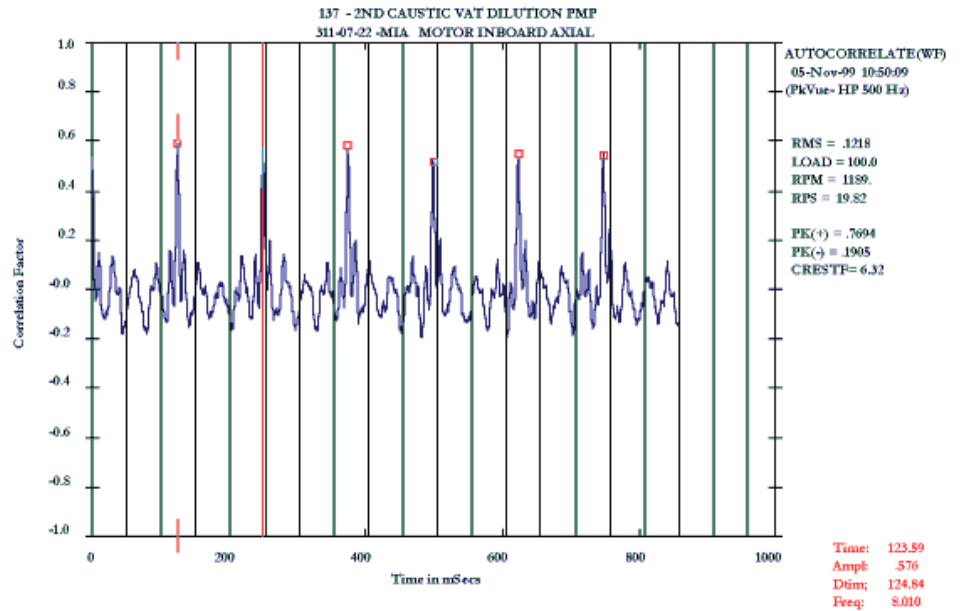
The autocorrelation coefficient data computed from the PeakVue time waveform are presented in Fig. 18. The only significant activity is the cage activity.

Figure 18. Autocorrelation coefficient from PeakVue time waveform of Figure 17.

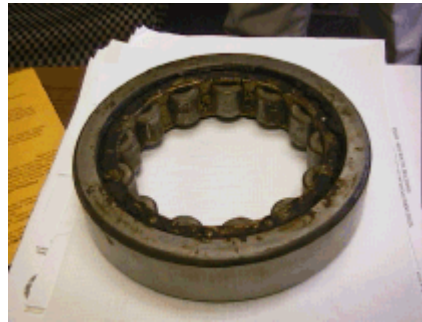
A photo of the defective bearing is presented in Fig. 19. The rolling elements show indication of "skidding," but the dominant problem is the "caked" residue of lubricant (grease).

Figure 19. Photography of the defective bearing highlighting the "caked" residue of lubricant and skid of roller 5.

This bearing is being replaced with a rolling ball element bearing. The problem of grease being "pushed out" is not uncommon with cylindrical rollers in low radial load applications.

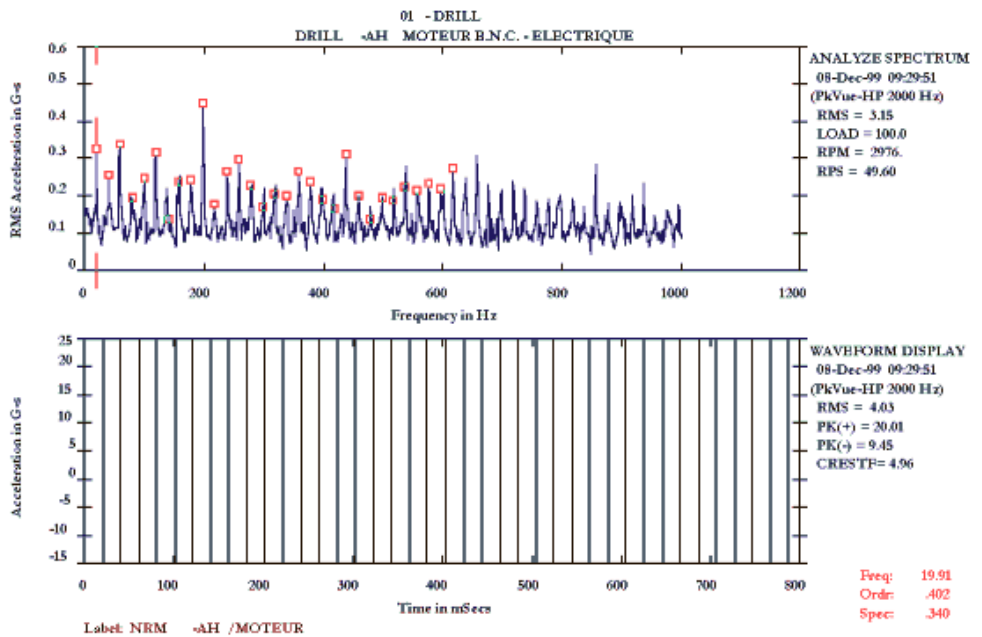
The PeakVue data taken with the sensor mounted vertically over the outbound bearing on the male 4 vane rotary screw are presented in Fig. 20. Given how the sensor was mounted, the 30 g peak impacts seen in the PeakVue time waveform are considered significant. The activity are primarily many harmonics of cage frequency. The autocorrelation coefficient data presented in Fig. 21 also identifies cage as the dominant source of the activity.

Figure 20. PeakVue Spectra and Time Waveform on the outboard bearing of the male rotor and simple stage compressor.

This type activity has been observed before in cases where a) lubrication problems are present, b) where heavy preloads are present, c) where out-of-round race ways are present, and d) where heavy thrust loads are present.

Given the "newness" of this compressor and lack of similar activity on the female rotary screw, the lubrication problem is placed low on the suspected source. This leads to the conclusion that there could be excessive thrust for the bearing or out-of-round race way. In any event, cage activity generally is an indicator of a developing problem and should be trended closely.

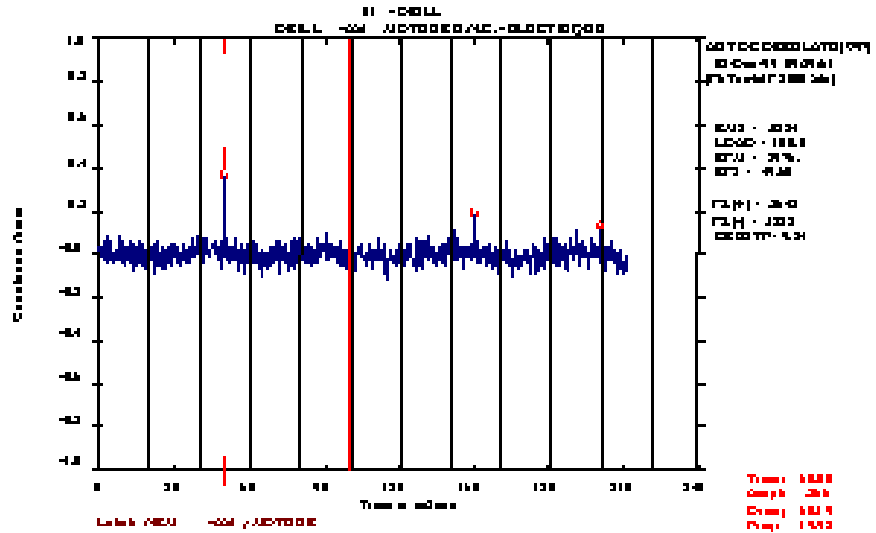
Figure 21. Autocorrelation coefficient from PeakVue time waveform of Figure 20.
