Triax Accelerometer for Route-Based Vibration Analysis

A newly-developed triax accelerometer developed specifically for route-based vibration data acquisition for industrial machinery condition monitoring is presented. The sensor incorporates a two pole (two feet) integral magnet such that it can be placed on a curved surface. When the newly-developed triax sensor is mounted on the curved surface of a machine, the bandwidths of all three sensors are sufficient to capture the mechanical vibration and limited stress wave activity. If the sensor is placed on a flat surface (mounting pad), the bandwidth of the Z axis is sufficient to capture the stress wave activity accompanying impacting, fatiguing and friction. Assuming a two channel data collector is employed, simultaneous two channel data acquisition can be executed such as Z-axis mechanical vibration paired with Z-axis stress wave analysis followed by X-axis paired with Y-axis mechanical vibration resulting in significant time savings.

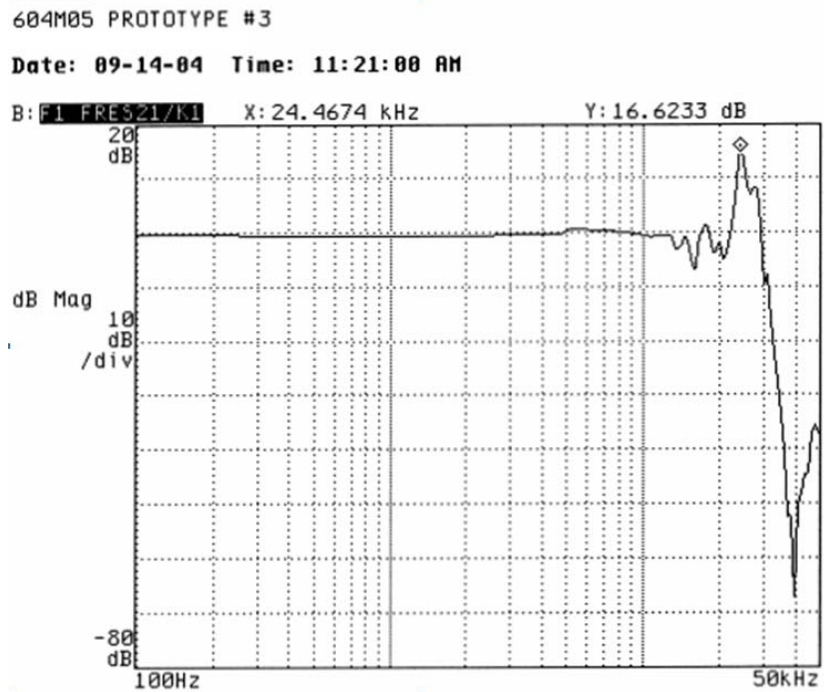
Figure 2. Frequency response sweep between 100 Hz and 50,000 for z-direction sensor in Triax accelerometer.

The frequency response sweep between 100 Hz and 50,000 Hz for the triaxial accelerometer are presented in Figure 2. The resonance for this sensor is around 24 kHz showing a peak around 10 dB at resonance. There is a decrease in response in the proximity of 15 kHz. The activity around the resonance will vary somewhat between sensors, but the key points are the z-axis sensor is within 3 dB at 10 kHz and remains responsive to 30 or so kHz. A reference 50 kHz frequency response sweep for a single axis sensor on flat surface is presented in Figure 3. The response is similar to the z-direction sensor of the triaxial accelerometer in the 10 kHz to 30 kHz range.

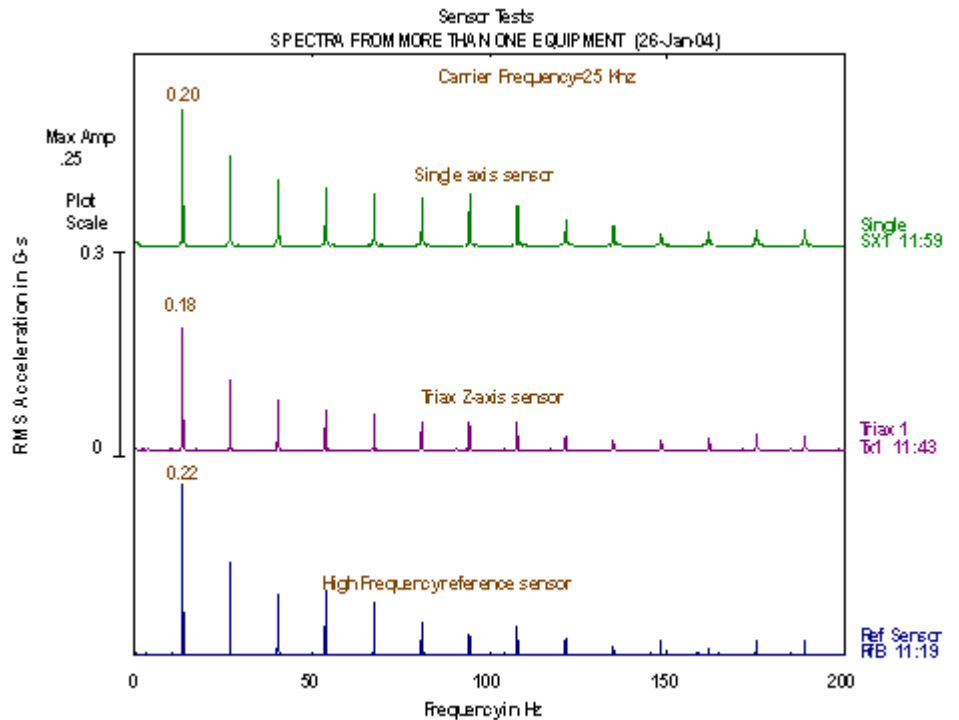
Figure 4. PeakVue response of high frequency accelerometer, z-axis of triax accelerometer and single axis accelerometer/flat rare earth magnet to an impulse excitation of 25 kHz carrier gated on 2 msec with a periodic rate of 13 per second.

The PeakVue™ spectral data acquired from the reference sensor, single axis sensor, and a triaxial (z direction) sensor for the case when the excitation frequency was 25 kHz are presented in Figure 4. The PeakVue spectral response of these three sensors with a second triaxial sensor at multiple carrier frequencies is tabulated in Table 1. The key observation is the z axis triaxial sensor is capable of detecting stress wave activity beyond the 25 kHz range which is sufficient to capture stress wave generated by impacting, fatiguing, and friction when mounted on a flat surface.

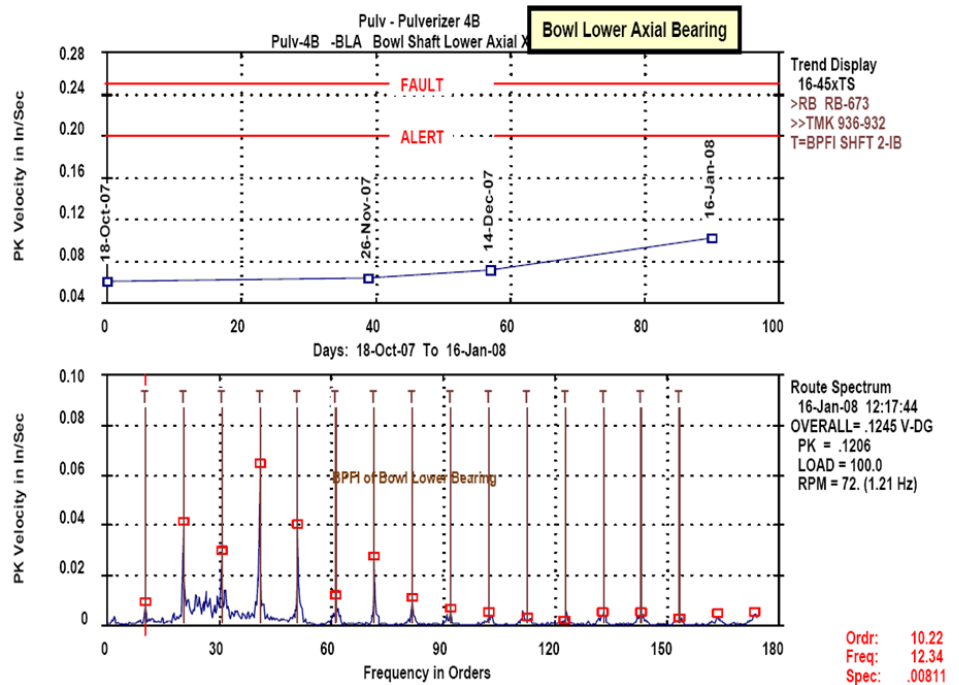
Figure 5. Velocity spectra data from z-axis sensor on Pulverizer Gearbox clearly indicating inner race bearing fault.

The velocity spectral data from the z sensor of the triax sensor placed on a curved surface on a Pulverizer gearbox are presented in Figure 5 clearly showing an inner race fault. The velocity spectral data acquired over a six month period from the same triax sensor mounted on the curved surface are presented in Figure 6. The defect was first observed in the December 14, 2007 data set and increased in severity level through the January 17, 2008 data set when the bearing was replaced. A photograph of the inner race from the

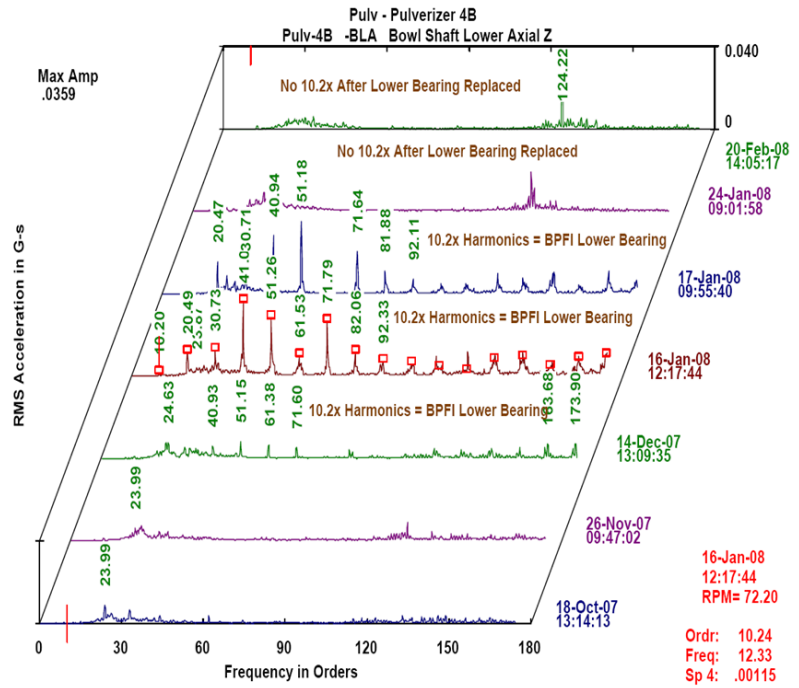
Figure 6. Water fall velocity spectral data from z-axis sensor on Pulverizer Gearbox over 6 month period with inner race fault present between December 14, 2007 and January 17, 2008 when bearing was replaced.

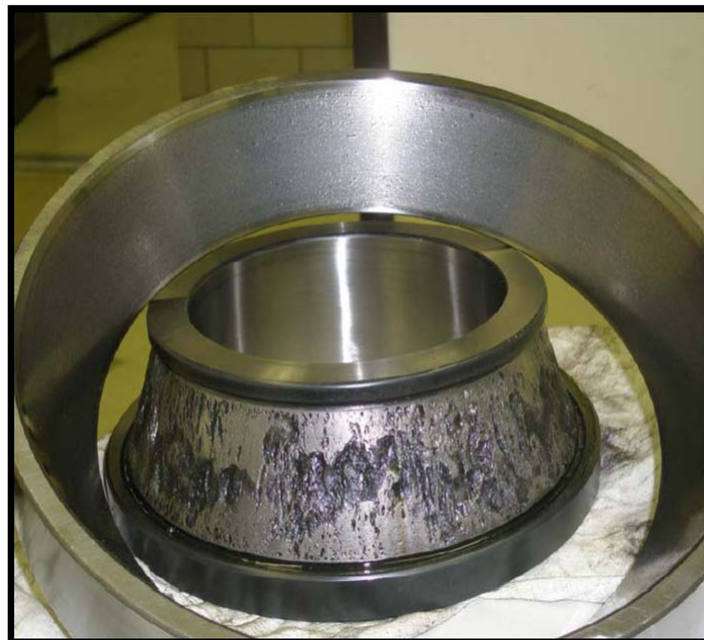
Figure 7. Photograph of the defective inner race from bearing removed from Pulverizer Gearbox following January 17, 2008 data set in Figure 6.

removed bearing is presented in Figure 7 which shows significant damage.

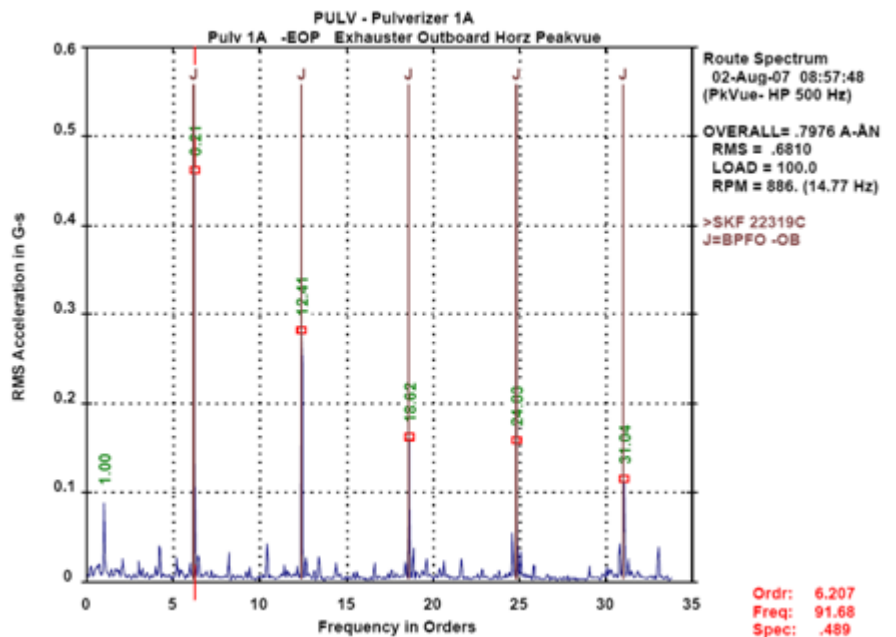
Figure 8. BPFO fault detected August 2, 2007 with PeakVue from Single Axis Accelerometer. Note slight amplitude modulation at tuning speed.

An outer race defect detected on August 2, 2007 employing PeakVue from single axis accelerometer mounted on pulverizer exhaust fan is presented in Figure 8. On October 22, 2007, the triax sensor was being used for collection of route data. The PeakVue spectra from this same exhaust fan are presented in Figure 9. The outer race defect is still obvious, but with less amplitude at the defect frequency. The 1-x component has grown slightly and there are obvious side banding (amplitude modulation) of the BPFO fault activity with the running speed suggesting possible unbalance may be increasing.

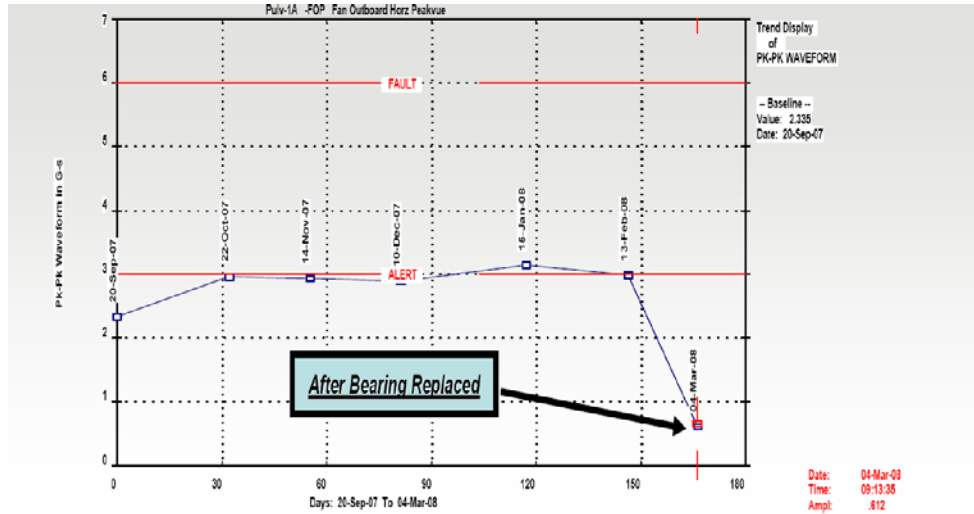
Figure 11. Peak g-level PeakVue trend data from z-axis sensor over 5.5 month period from same measurement point from which PeakVue spectra data in Figure 10 acquired.

PeakVue spectra from the z sensor in triax accelerometer are presented in Figure 10 from pulverizer exhaust fan clearly showing BPFO fault. The peak g-level trend data from the PeakVue waveform are presented in Figure 11 over a 5+ month period. The bearing was replaced near March 4, 2008 showing significant decrease in the peak g-level amplitude. A photograph of the defective bearing (showing fluting) is presented in Figure 12.

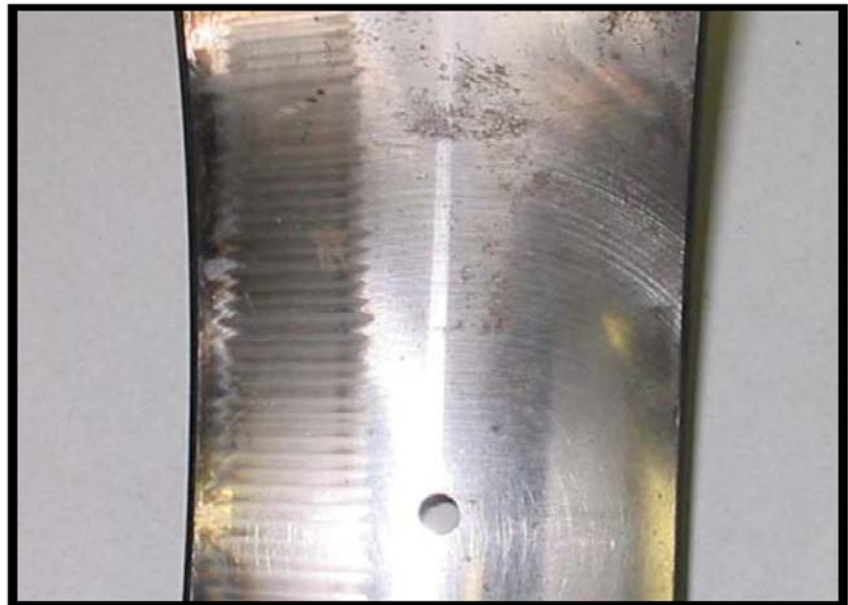
Figure 12. Defective bearing (fluting) from Pulverizer exhaust fan where data presented in Figures 10 and 11 were acquired.
