PeakVue Analysis for Antifriction Bearing Fault Detection

Peak values (PeakVue) are observed over sequential discrete time intervals, captured, and analyzed. The analyses are the (a) peak values (measured in g's), (b) spectra computed from the peak value time waveform, and (c) the autocorrelation coefficient computed from the peak value time waveform.

Case studies of various classes of faults are presented to illustrate the PeakVue methodology. The classes of faults are (a) inner race defects, (b) outer race defects, (c) rolling element defects, and (d) cage related defects. All three analysis tools enable the identification of the defect and often the severity of the defect.

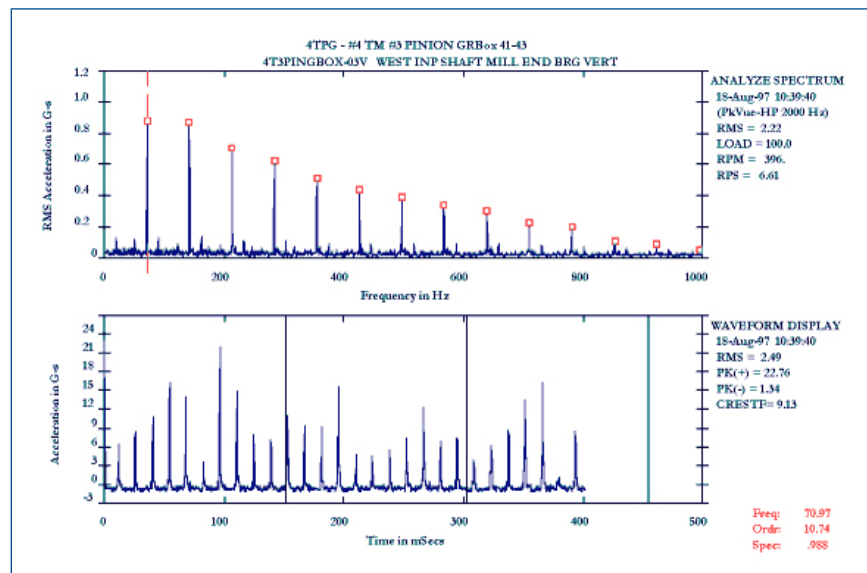
The PeakVue spectra and time waveform data are presented in Fig. 1. A high pass filter of 1000 Hz was used. Significant activity at the outer race defect frequency with many harmonics is present. The impact levels are as high as 37 g's.

Figure 1: PeakVue Spectra and time waveform from input shaft of pinion stand gearbox

Although many harmonics are present in the spectral data, it is obvious from the PeakVue time waveform that the time between impacts corresponds to the outer race fault frequency (the harmonics are of no physical significance). This is also demonstrated in the autocorrelation coefficient function presented in Fig. 2.

The impacting levels trended from 18 g's in July to a high of 37 g's in September. The levels had decreased to 14 g's in October prior to a bearing replacement.

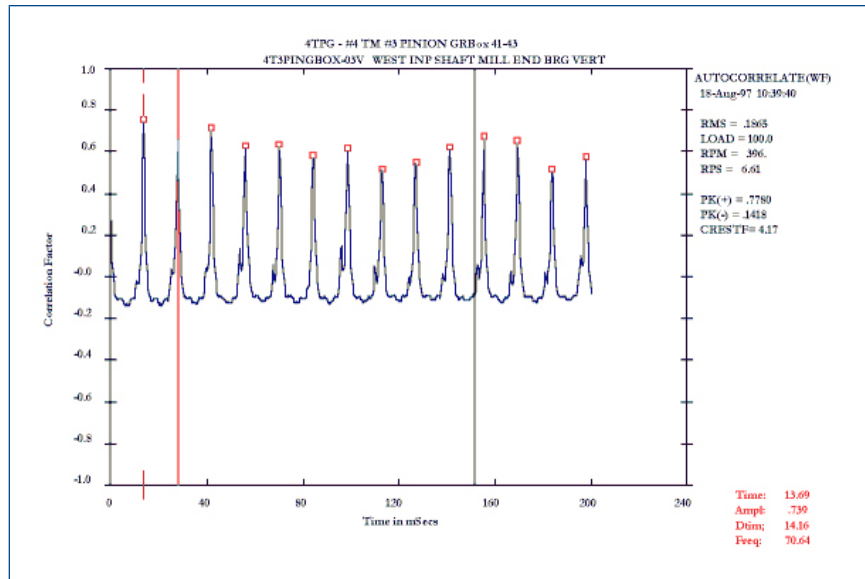
Figure 2: Autocorrelation coefficient from PeakVue time waveform in Fig 1

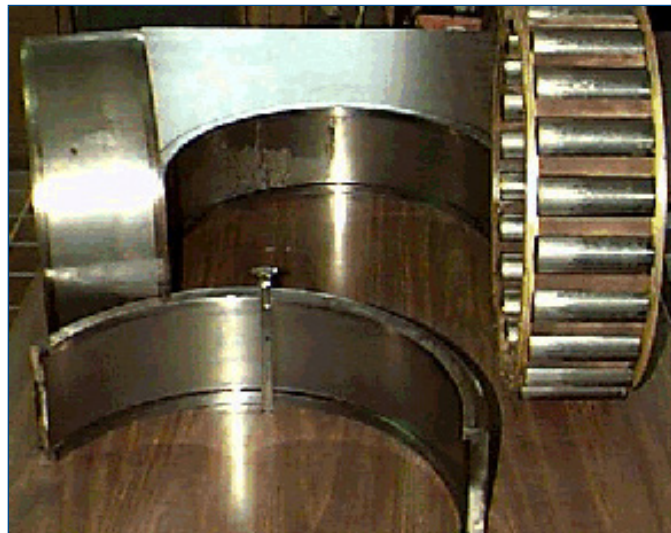
Figure 3: Photograph of defective bearing from the inlet of pinion stand gearbox

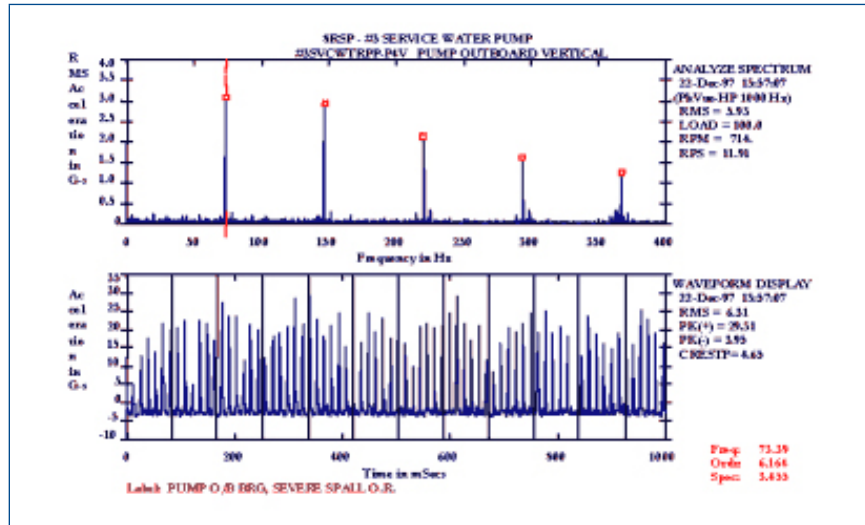
The second case study is from a centrifugal service water pump rated at 12000 gpm driven by an 8 pole 700 hp motor. Normal route-based vibration monitoring identified an outer race defect of reasonably low level (the peak-to-peak g level was 1.5 g's). The fault was identified as "alert" and hence was to be trended. On December 8, 1997, PeakVue was employed and showed both outer and inner race defects with a signal level of 10 g's. A second PeakVue reading was taken on December 22, 1997 and is presented in Fig. 4. The impacting levels had increased to 33 g's. The pump was then placed on the "fault" level and the bearing was replaced. The autocorrelation coefficient computed from the PeakVue time waveform is presented in Fig 5. The autocorrelation coefficient data shows the only activity of significance is the impacting from the outer race defect.

Figure 4: PeakVue spectra and time waveform from outboard on service water pump

In this case, normal vibration data did identify the fault; however, the low levels observed did not place the fault at a level of significant concern. The impacting levels identified in PeakVue, excess of 30 g's, raised the concern level and initiated planning for replacement.

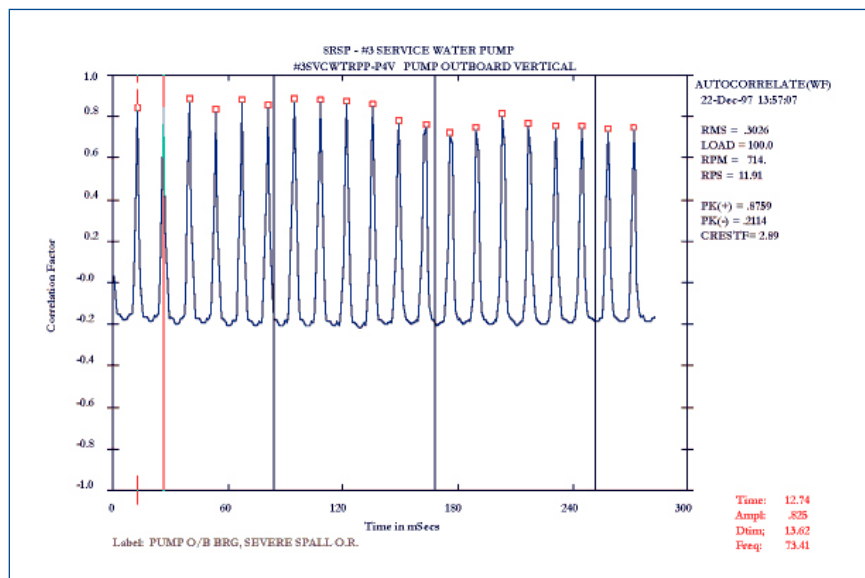
Figure 5: Autocorrelation coefficient from PeakVue waveform in Figure 4.

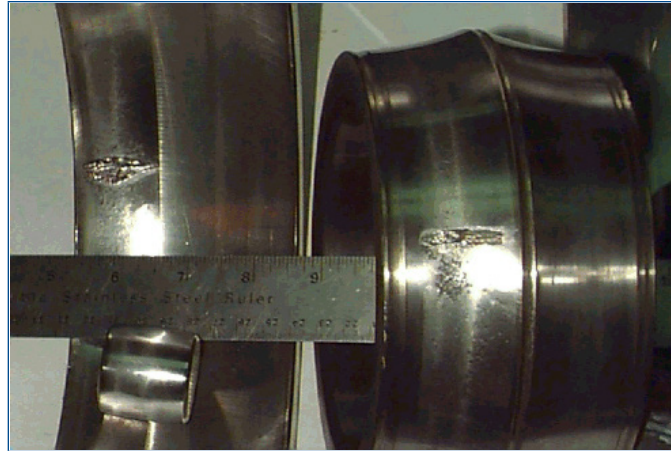
Figure 6: Photograph of defective service water pump bearing, showing inner and outer race spalling.

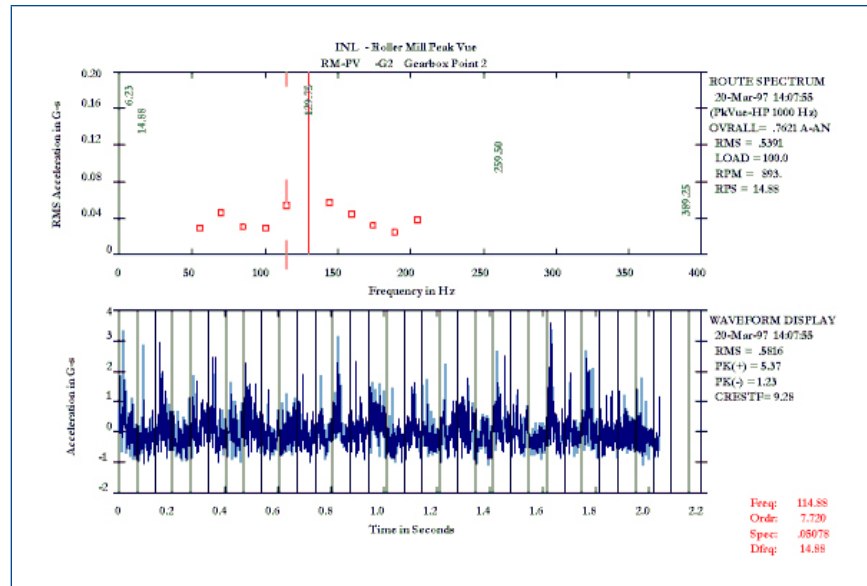
The PeakVue data acquired March 20, 1997 are presented in Fig. 7. The cage activity at 6.23 Hz (0.42 orders) is identified. The inner race defect (129.75 Hz) at 8.72 orders is being sidebanded by running speed. The inner race defect was not detected in the normal spectral analysis.

Figure 7. PeakVue spectra and time waveform from inlet of crusher gear box.

The autocorrelation coefficient function computed from the PeakVue time waveform in Fig. 7 is presented in Fig. 8. The inner race defect is clearly evident with amplitude modulation at running speed. The peak g levels for an inner race are generally not as large as for those accompanying an outer race defect. This is expected since the stress waves accompanying an inner race defect will experience attenuation in reaching the outer peripherals (where the sensor is attached) of the machine.

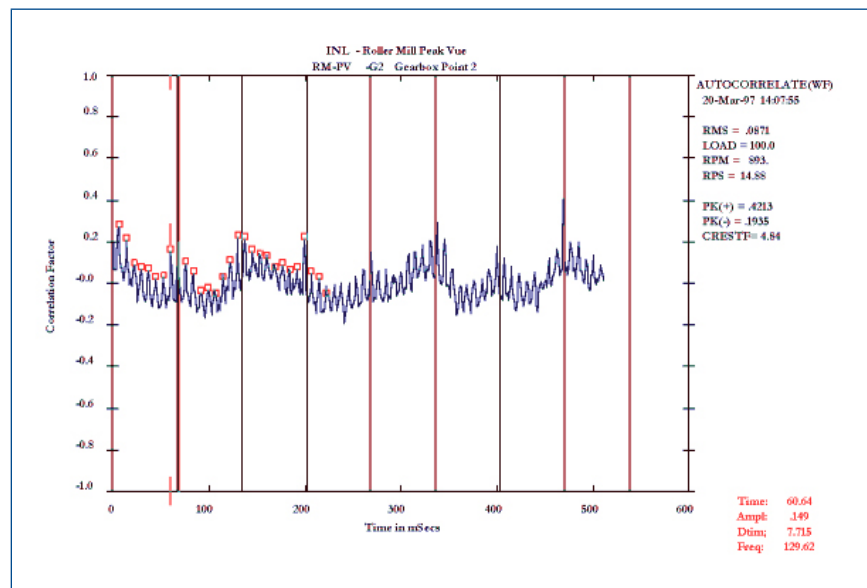
Figure 8. Autocorrelation coefficient from PeakVue time waveform of Figure 7.

The bearing was replaced in June, 1997. The inner race had deep spalling over an approximate 1.5 area.

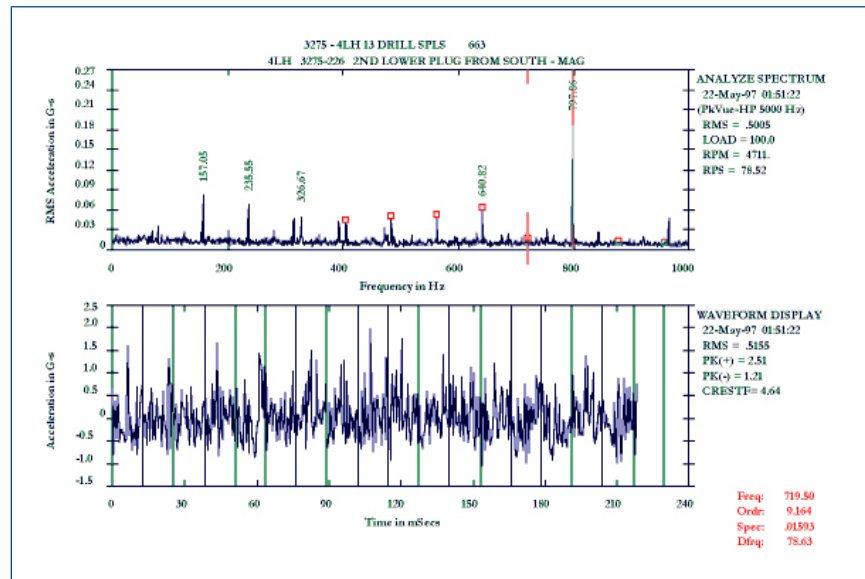
Figure 9. PeakVue spectra and time waveform from a spindle on a 13 multi-drill head spindle.

The PeakVue spectra and time waveform for a spindle with a confirmed inner race defect are presented in Fig. 9. The inner race defect at 797.86 (10.2 orders) Hz is identified with side banding (twice running speed is dominant). The autocorrelation coefficient function computed from the PeakVue time waveform is presented in Fig. 10. The dominant activity here is at the inner race defect frequency. The bearing was replaced. The bearing had deep spalling on the inner race.

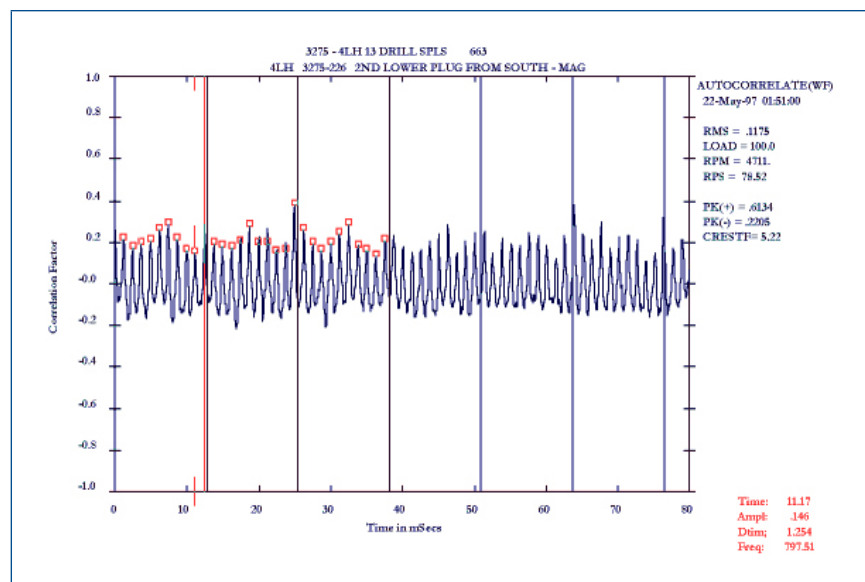
Figure 10. Autocorrelation coefficient from PeakVue time waveform acquired on the spindle of Figure 9.

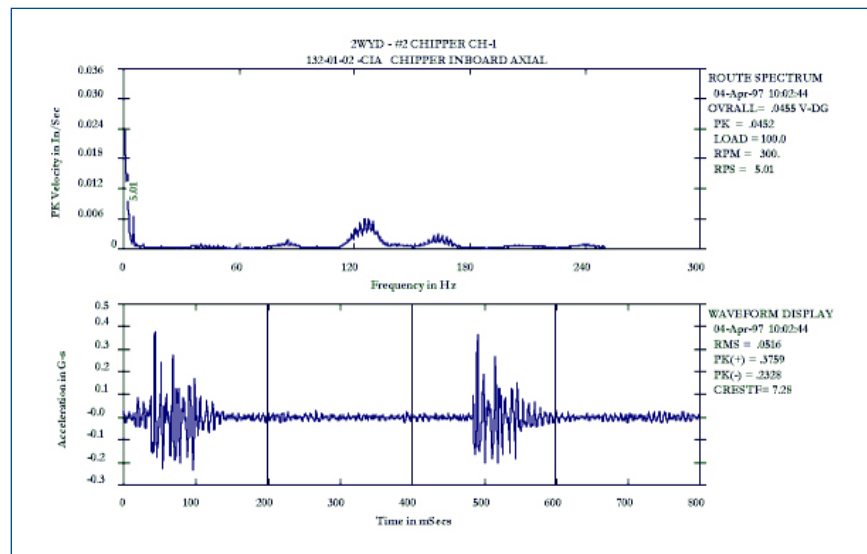
Following a shutdown where work was done on this chipper machine, the acceleration time waveform for a 500 Hz bandwidth spectra indicated some impacting may be occurring, see Fig. 11. The p-p g levels were less than 1 g which are not judged to be significant. The velocity spectra had a low 1x component but there were no obvious bearing faults.

Figure 11. Velocity spectra and acceleration time wave form from inboard axial on a chipper.

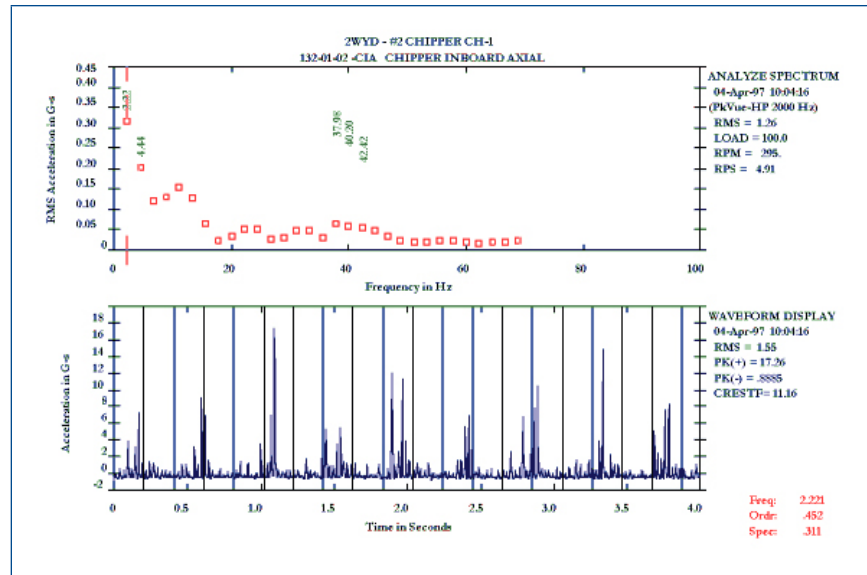
Figure 12. PeakVue Spectra and time waveform from inboard axial on chipper.

A PeakVue data set was acquired at about the same time using a high pass filter of 2000 Hz. The resulting PeakVue spectra and time waveform are presented in Fig 12. The impacting level is near 20 g's and the cage and twice ball spin frequencies are dominant. This pattern is indicative of two impacts per revolution of the ball that is passing through the load zone at the cage repetition rate. From the PeakVue spectral data, it is not obvious whether the 38, 40.2, or 42.4 Hz peaks are representative of twice ball spin. The autocorrelation coefficient function data, presented in Fig. 13 clearly identifies the dominant activity is at 40.2 Hz which is twice the ball spin frequency. The autocorrelation coefficient data also clearly shows the defective ball going in and out of the load zone at the cage turning speed.

The root cause of this problem was found to be improper grounding of an electrical welder used during the recent outage.

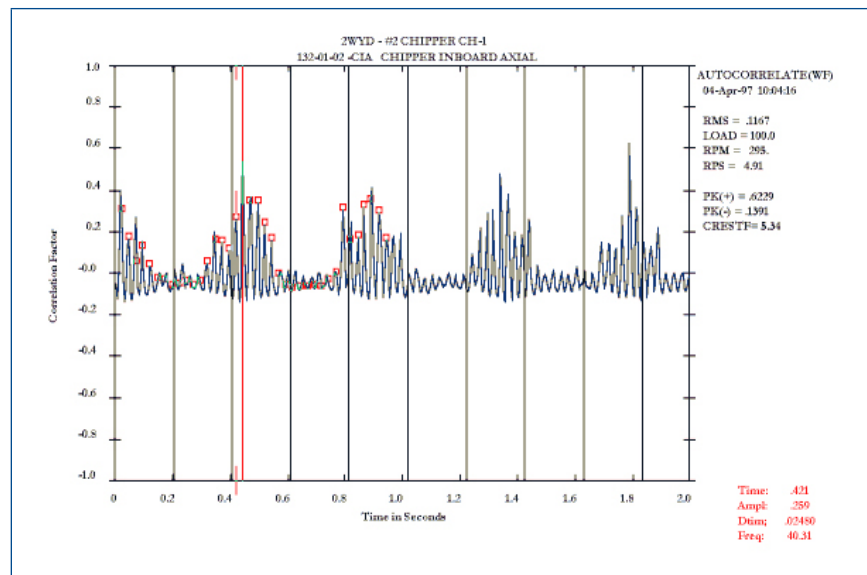
Figure 13. Autocorrelation coefficient from PeakVue time waveform of Figure 12.

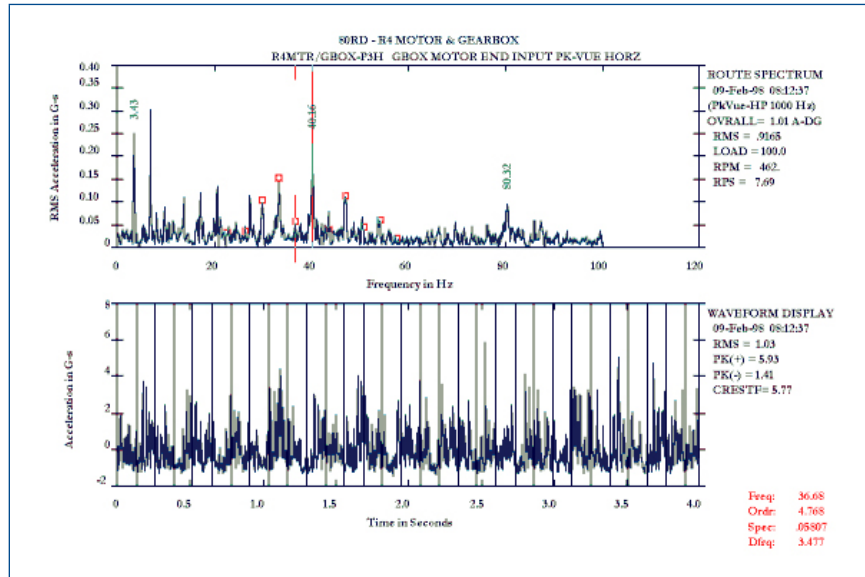
When data was acquired on the inlet pinion shaft bearing on January 2, 1997, impacts in the 6 g range were detected with the PeakVue spectra showing ball spin fault modulated by cage. On February 9, 1997, the impacting level had increased to 9 g's. The PeakVue data are presented in Fig 14. The ball spin fault frequency is at 40.4 Hz and cage at 3.43 Hz. The autocorrelation coefficient is presented in Fig. 15 which emphasizes the cage and ball activity. A photo of the defective bearing is presented in Fig. 16.

Figure 14. PeakVue Spectra and time waveform from inboard pinion rougher gear box.

The bearing was replaced and PeakVue data acquired on February 12, 1997. The impacting level had decreased to less than 1 g. The normal vibration never showed any indication of a bearing problem.

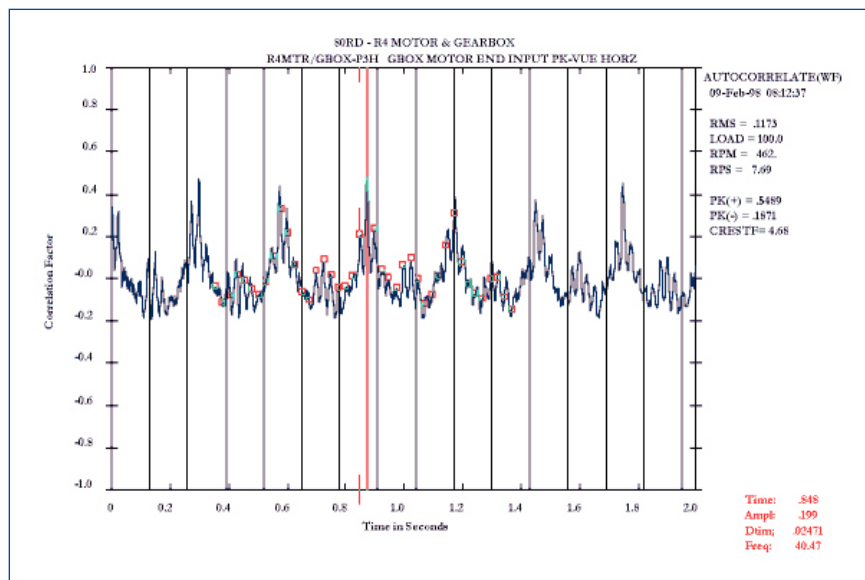
Figure 15. Autocorrelation coefficient from PeakVue time waveform of Figure 14.

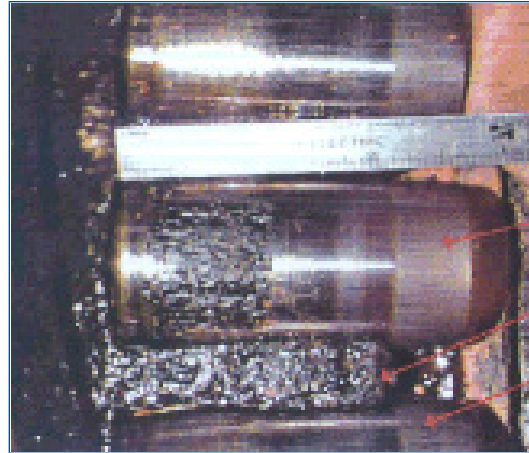
Figure 16. Photograph of defective bearing highlighting the rollers.

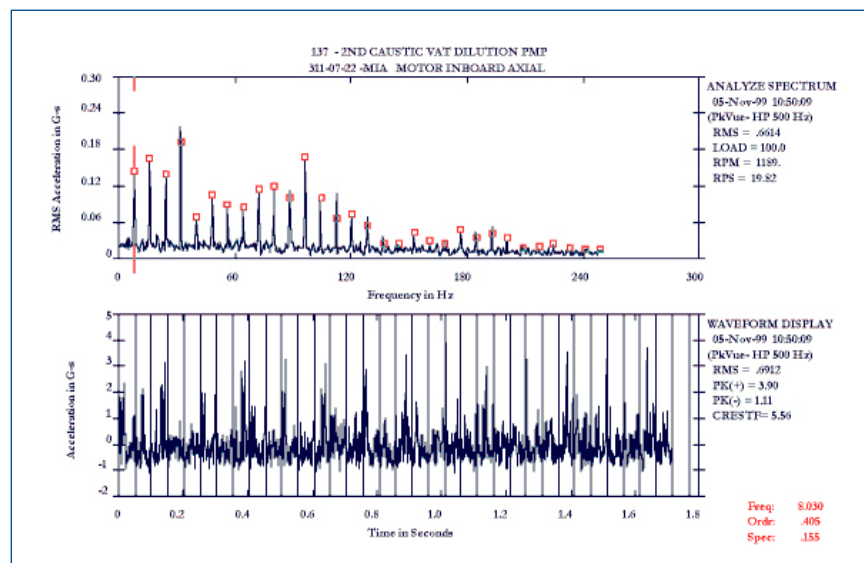
The PeakVue data from the inboard bearing on a motor (150 hp) directly driving a centrifugal pump are presented in Fig. 17.

Figure 17. PeakVue spectra and time waveform from Motor (Inboard Axial) driving direct coupled centrifugal pump.

The impacting levels are 5 g's which are not excessive for this speed machine but definitely indicative of a problem. The spectral data is dominated with cage and many harmonics. This is a NSK NU 318 bearing which has 13 rolling elements.

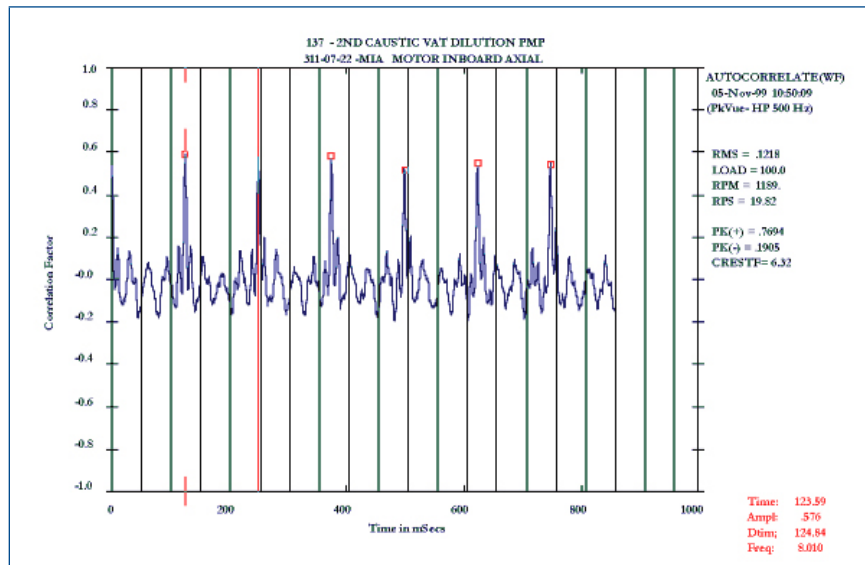
The autocorrelation coefficient data computed from the PeakVue time waveform are presented in Fig. 18. The only significant activity is the cage activity.

Figure 18. Autocorrelation coefficient from PeakVue time waveform of Figure 17.

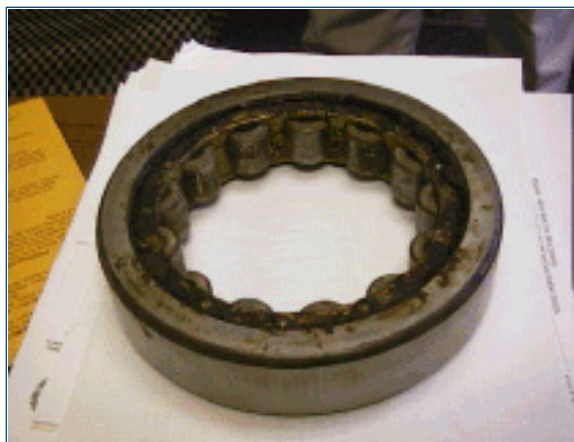
A photo of the defective bearing is presented in Fig. 19. The rolling elements show indication of “skidding,” but the dominant problem is the “caked” residue of lubricant (grease).

Figure 19. Photography of the defective bearing highlighting the “caked” residue of lubricant and skid of roller 5.

This bearing is being replaced with a rolling ball element bearing. The problem of grease being “pushed out” is not uncommon with cylindrical rollers in low radial load applications.

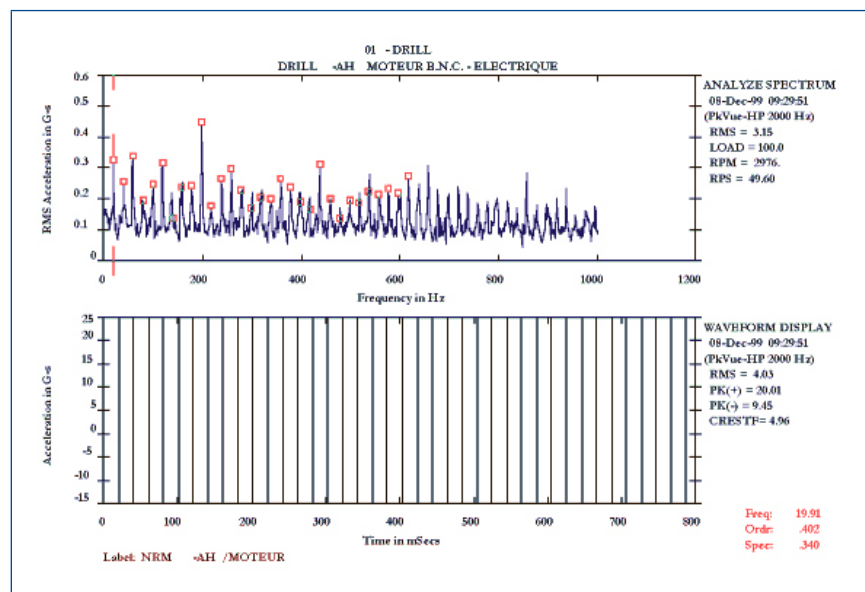
The PeakVue data taken with the sensor mounted vertically over the outbound bearing on the male 4 vane rotary screw are presented in Fig. 20. Given how the sensor was mounted, the 30 g peak impacts seen in the PeakVue time waveform are considered significant. The activity are primarily many harmonics of cage frequency. The autocorrelation coefficient data presented in Fig. 21 also identifies cage as the dominant source of the activity.

Figure 20. PeakVue Spectra and Time Waveform on the outboard bearing of the male rotor and simple stage compressor.

This type activity has been observed before in cases where a) lubrication problems are present, b) where heavy preloads are present, c) where out-of-round race ways are present, and d) where heavy thrust loads are present.

Given the “newness” of this compressor and lack of similar activity on the female rotary screw, the lubrication problem is placed low on the suspected source. This leads to the conclusion that there could be excessive thrust for the bearing or out-of-round race way. In any event, cage activity generally is an indicator of a developing problem and should be trended closely.

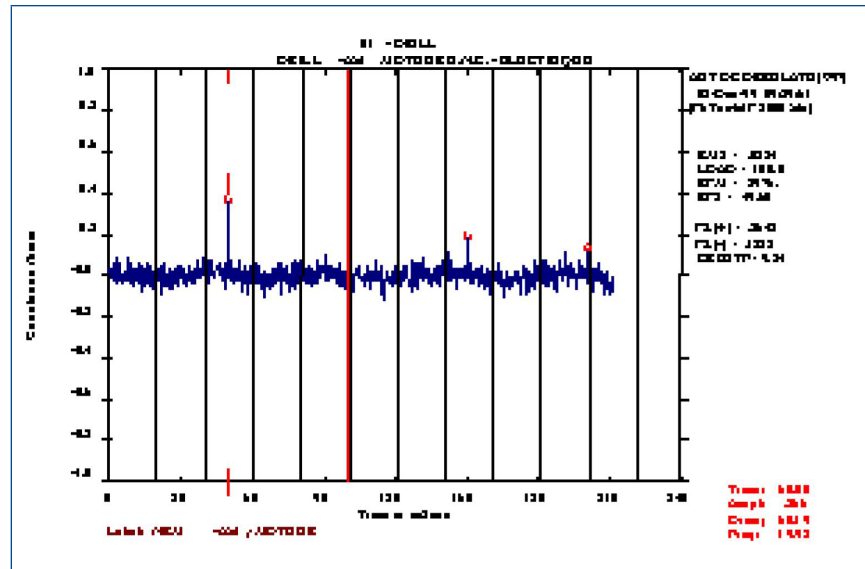
Figure 21. Autocorrelation coefficient from PeakVue time waveform of Figure 20.
