Magmeter Diagnostics Reduce Maintenance Costs Associated with Corrosion of Ground Lead Connection

Corrosion within a Chlor-Alkali Plant

A major Chlor-Alkali plant

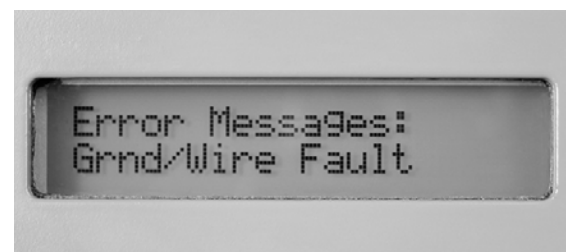
The Rosemount DA1 diagnostic detected ground wire corrosion, which improved maintenance practices.

Ground/Wiring Diagnostic

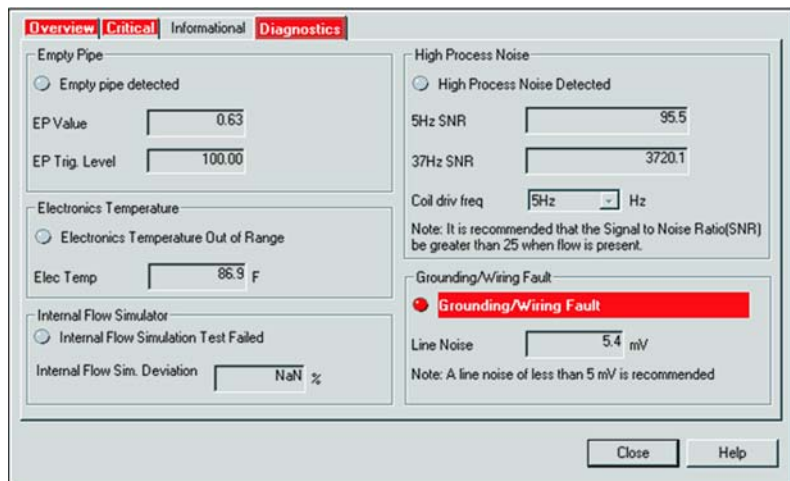
Ground/Wiring Fault Diagnostic in AMS Suite

It was suggested that the Rosemount 8712D transmitter with the DA1 high process noise and ground/wire fault detection diagnostics be used to troubleshoot the existing magmeter installation. The DA1 diagnostic can be run from the local operator interface or AMS[®] Suite. The diagnostics indicated a ground/wiring fault. Upon further inspection, it was realized that the same ground wires were utilized with the new flowtube sensor resulting in a bad ground connection. The original flow tube and transmitter were replaced when the source of the problem was corroded ground wires.
