Installing Predictive Vibration Monitors

By Glenn Hauck, Elk River Station, Great River Energy; and Craig Truempi and Pat Stockert, Novaspect Inc.

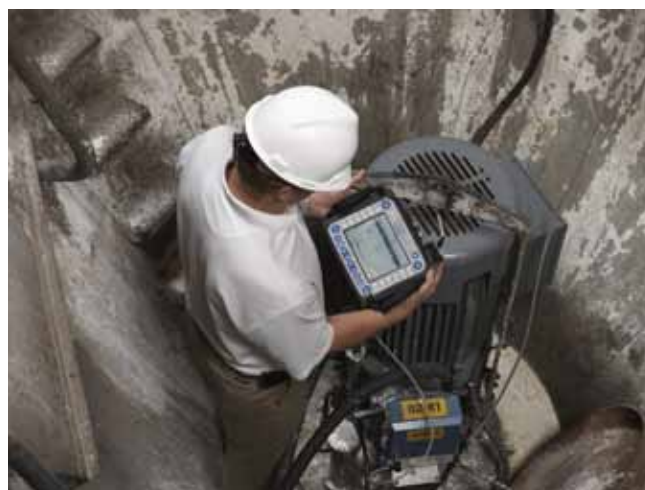
Using a machinery health analyzer to retrieve spectral data files captured by the continuous vibration transmitter at the Elk River Station. Photo, Novaspect Inc.
