Metals Manufacturer Increases Facility Availability with High Performance Guided Wave Radar

Alumina Powder Storage Silo Level

Application Characteristic: Low dielectric, extreme dust conditions, 24 m (79-ft.) silo height

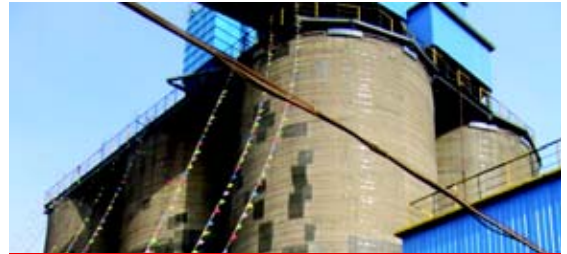
The patented Direct Switch Technology of the 5303 provides more signal over the long range to the surface than standard Guided Wave Radar units. In addition, the 5303 Probe End Projection is paired with Direct Switch Technology to ensure a reliable signal.

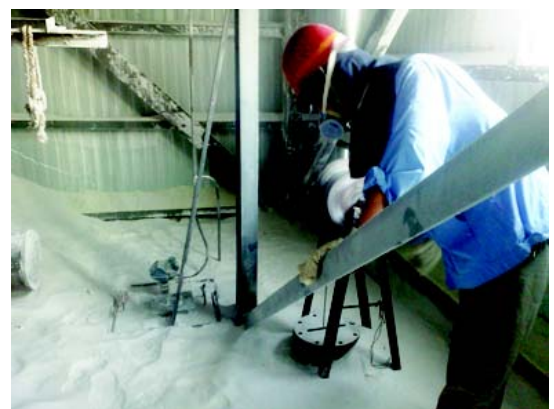
This newly installed Rosemount 5300 eliminated future overfill

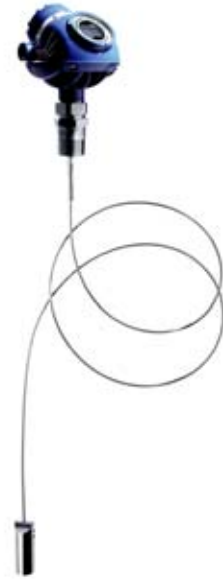
The Rosemount 5300 Guided Wave Radar with a Single Flexible Probe

The Rosemount 5303 Guided Wave Radar with a single flexible probe was installed for this customer. Guided Wave Radar technology handled the high dust environment.
