Metals Manufacturer Increases Facility Availability with High Performance Guided Wave Radar

Alumina Powder Storage Silo Level

Application Characteristic: Low dielectric, extreme dust conditions, 24 m (79-ft.) silo height

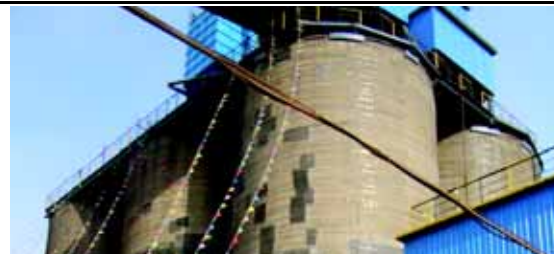
The Direct Switch Technology of the 5303 provides more signal over the long range to the surface than standard Guided Wave Radar units. In addition, the 5303 Probe End Projection is paired with Direct Switch Technology to ensure a reliable signal.

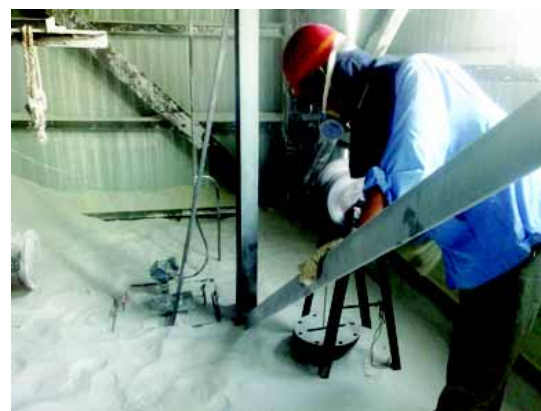
This newly installed Rosemount 5300 eliminated future overflow

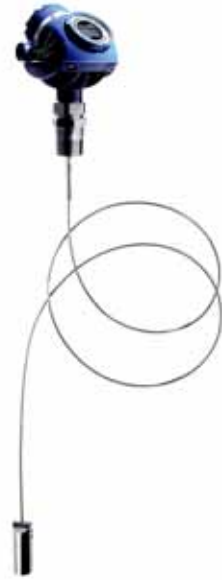
The Rosemount 5300 Guided Wave Radar with a Single Flexible Probe

The Rosemount 5303 Guided Wave Radar with a single flexible probe was installed for this customer. Guided Wave Radar technology handled the high dust environment.
