Remote Mount Display & Interface capability enables optimal separator measurement

Rosemount 3051S Pressure Transmitters with Direct Mount 1199 FFW Seals and Remote Mount LCD Display & Interface

Level measurement on coalescer filter separator

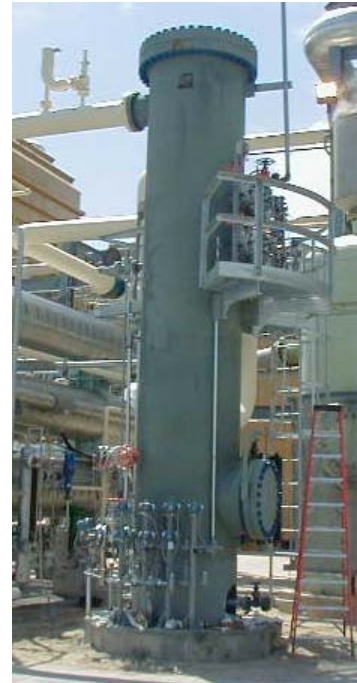
Rosemount 3051S

- Three 3051S pressure transmitters with direct mount flush flanged seals installed at the very bottom of the separator to measure level in the collection chamber. A redundancy voting scheme (2 out of 3 must agree) would be utilized as an added safety precaution.
- One 3051S differential pressure transmitter with dual flush flanged seals installed across the filter to identify clogging (rising differential pressure indicates the filter is clogging.)
- Three 3051S pressure transmitters with direct mount seals installed several feet from the bottom of the separator to measure the level of the coalescing filter (2 out of 3 must agree voting scheme).

Remote mount LCD display and interface on all seven transmitters for local indication at grade and ease-of-use for instrument technicians.
